**Weapon System Technical, Logistical, and Sustainment Support
FA8601-05F-0011**

**Subtask 024: Testing Cadmium Alternatives for High
Strength Steel: Phases II and III Testing**

**Testing Cadmium Alternatives for High Strength Steel Phase
II Joint Test Report**

November 23, 2009

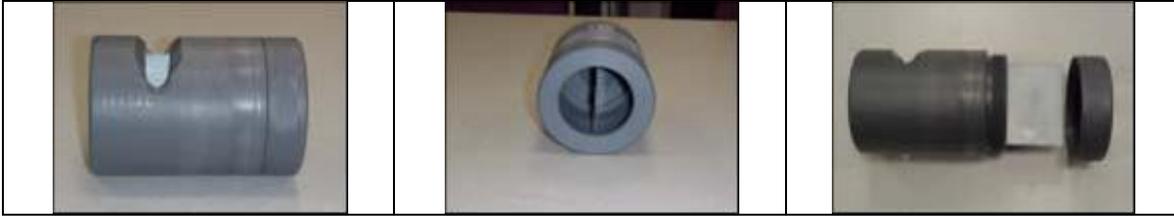
Fixture: Fixtures were constructed to the dimensions shown in Figure 1. The fixtures were made from Teflon, with the exception of the fixtures for electroplated Al. These fixtures were made by the vendor, to the same dimensions, to ensure that the fixture would not react with the electroplating bath. In both cases, the fixtures were constructed from a section of pipe with one capped end. Slots were cut into the interior to allow a 3 inch x 5 inch test panel to slide snugly into the pipe. A threaded open cap closed off the fixture.

Figure 1. Fixture for Throwing Power and Alloy Composition Test

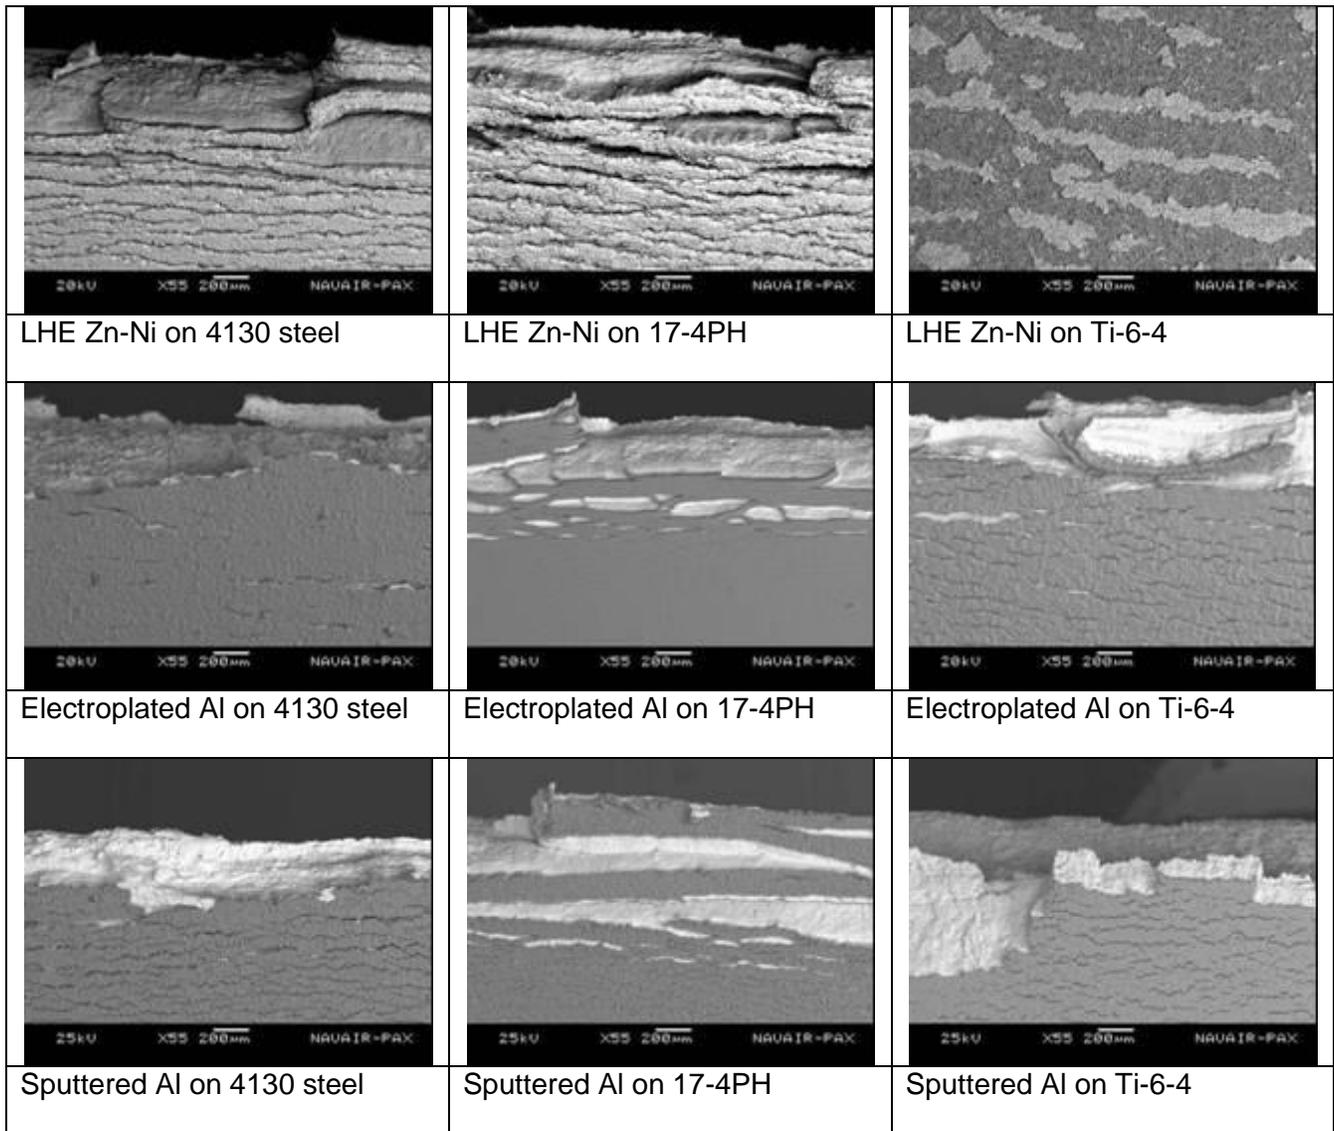
Figure 2. Low Magnification SEM Images of Bend Samples (55X)

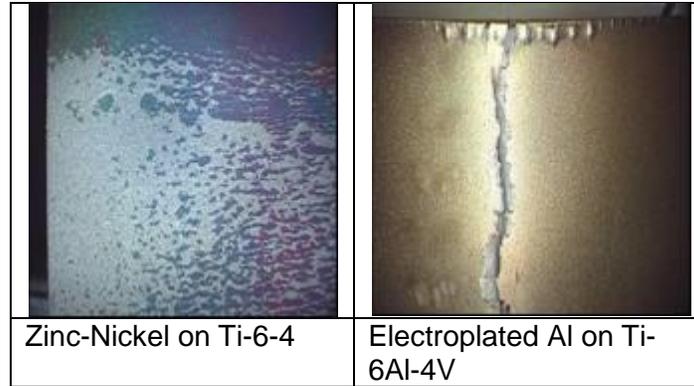
Figure 3. Photos of Failure Modes of Alternative Coatings (no magnification)

It is evident from Table 16 that the coatings tested generally displayed good adhesion to each substrate, though two failures were noted on titanium substrates. The plated and sputtered Al coatings performed well on most substrates as may be observed in the low magnification SEM images shown in Figure 2. Though cracks appeared in the Al coatings near the fracture surface due to the severe deformation, they were not able to be lifted with a sharp blade. On Ti-6Al-4V, however, the electroplated Al coating buckled and lifted along the sides of the bend sample up to 0.5 inch away from the fracture plane (Figure 3). These areas could be removed with a blade. According to the manufacturer, the electroplated Al had been deposited over a nickel strike bond layer. The sputtered Al coating performed well on titanium. The LHE Zn-Ni plating performed well on 17-4 PH stainless steel and 4130 steel, although the plating flaked off the Ti-6Al-4V substrate before one full 90 degree bend of the substrate. The coating dusted off in 0.02 – 0.04 inch flakes, and exhibited spalling beyond 0.375 inch from the fracture plane. It should be noted that titanium is a difficult substrate for activation and plating, and that the failures experienced on these substrates might be attributable to pretreatment rather than coating properties.

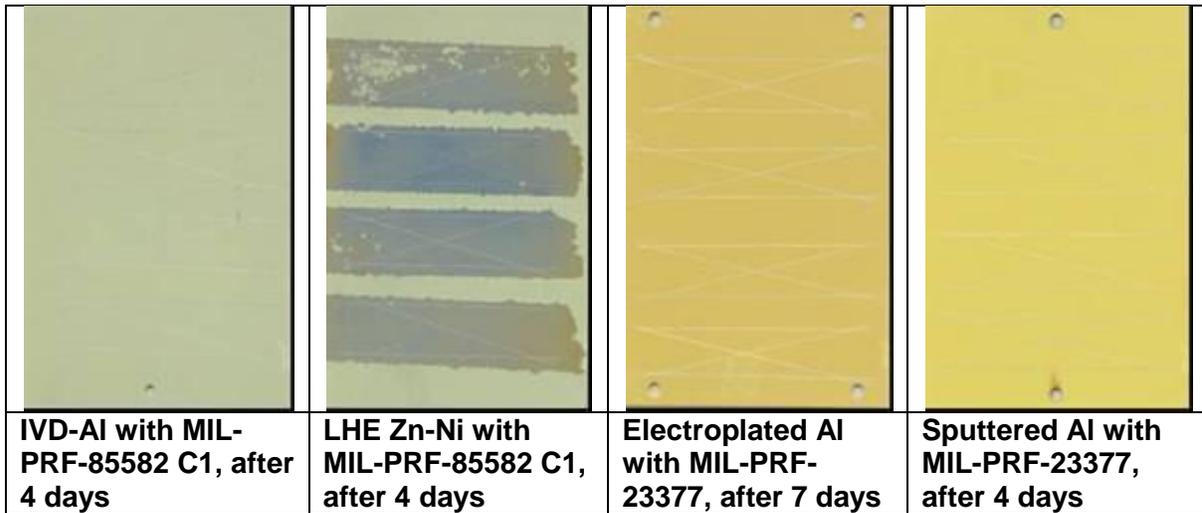
Figure 4. Representative Photos of Wet Tape Adhesion Panels

All inorganic coatings passed the JTP criterion for paint adhesion with ratings no less than 4.8 in the one day ambient temperature test. Additionally, all of the chromate post-treated Al coatings performed very well up to the seven day highest temperature test with typical ratings of 5.0. The LHE Zn-Ni coating exhibited slightly lower average paint adhesion values with MIL-PRF-23377 primer in the elevated temperature tests (4.0-4.4 ratings), but performed very well with the non-chromate primer MIL-PRF-85582 Class N (5.0 values). Poor adhesion was observed on the Zn-Ni with MIL-PRF-85582 Class C1, with primer blistering and substantial coating removal by the tape. All of the panels painted and tested in this study were treated the same prior to painting, as they were unwrapped from the coater's packaging the day prior to primer application. Typically, the panels were individually wrapped and sealed in Ziploc bags, thus the delay observed prior to painting was similar for each coating.

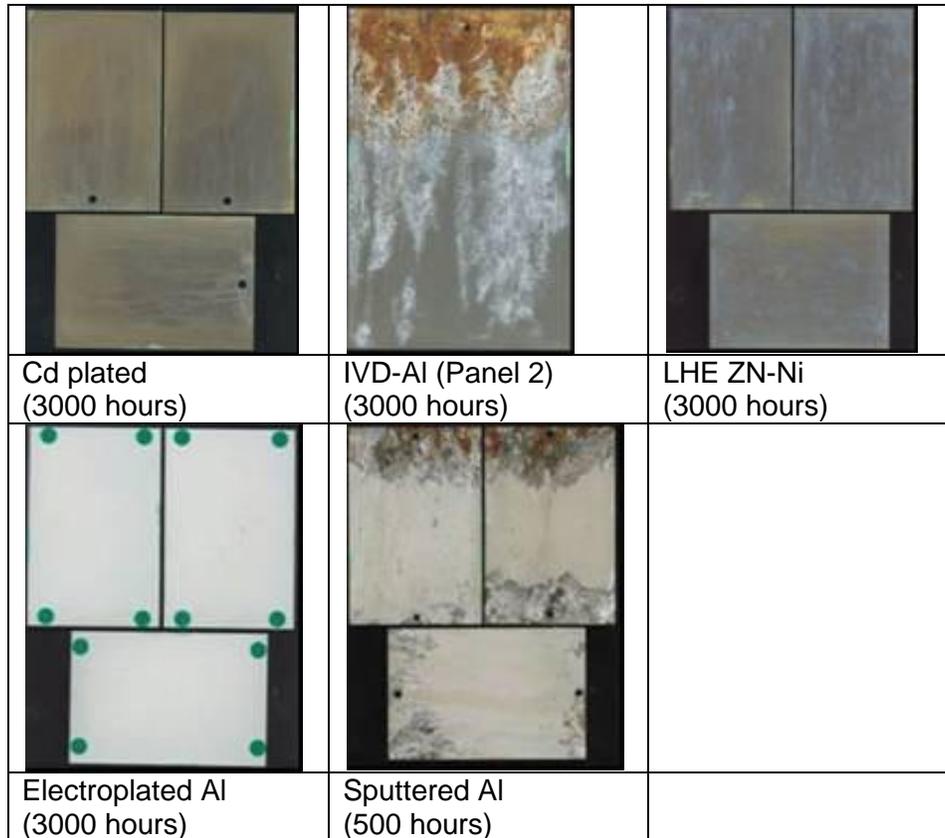
Figure 5. Photos of Unscribed Corrosion Resistance Panels After Exposure

The results listed in the table show that the Cd-plated panels met the specification of showing no rust after 3000 hours salt spray exposure. LHE Zn-Ni also performed well,

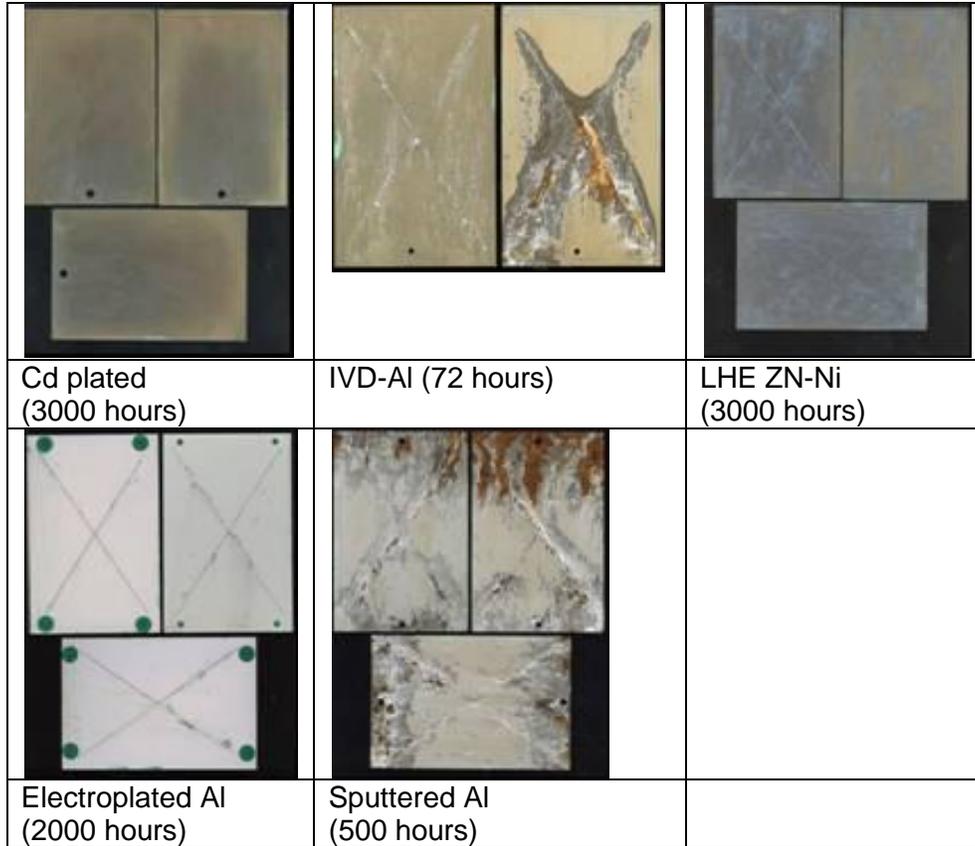
Figure 6. Photos of Scribed Corrosion Resistance Panels after Exposure

The results obtained for the scribed panels were very similar to the results for the unscribed panels. The Cd-plated panels did not exhibit any damage from exposure, as expected. The LHE Zn-Ni received the next highest rating, with some sacrificial coating breakdown but no rust. The electroplated Al followed, but two of three panels had to be pulled prior to 3000 hours due to significant rust. Once again, the IVD-Al and sputtered Al panels had the most significant corrosion present, and testing was terminated at 1000 hours or less.

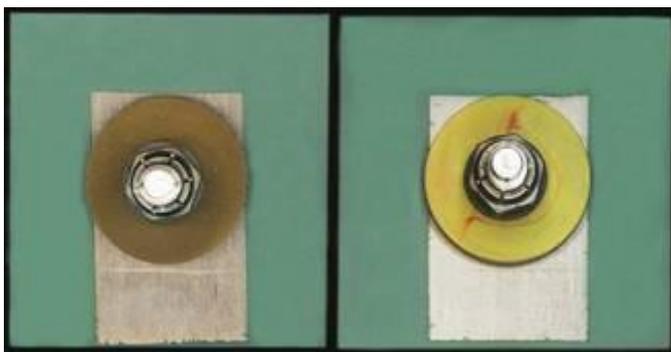
In order to ensure that the assembly was securely held together, a torque wrench was used to tighten the nut to a reading of 70-80 inch-pound (in-lb). The electrical resistivity between the bare area on the test block and the scribed test washer was then measured with an ohmmeter, where the electrical resistivity in all cases was less than one milliohm. A photo of the assembled test fixtures is located in Figure 7.

Figure 7. Representative Photos of Test Fixture Assembly

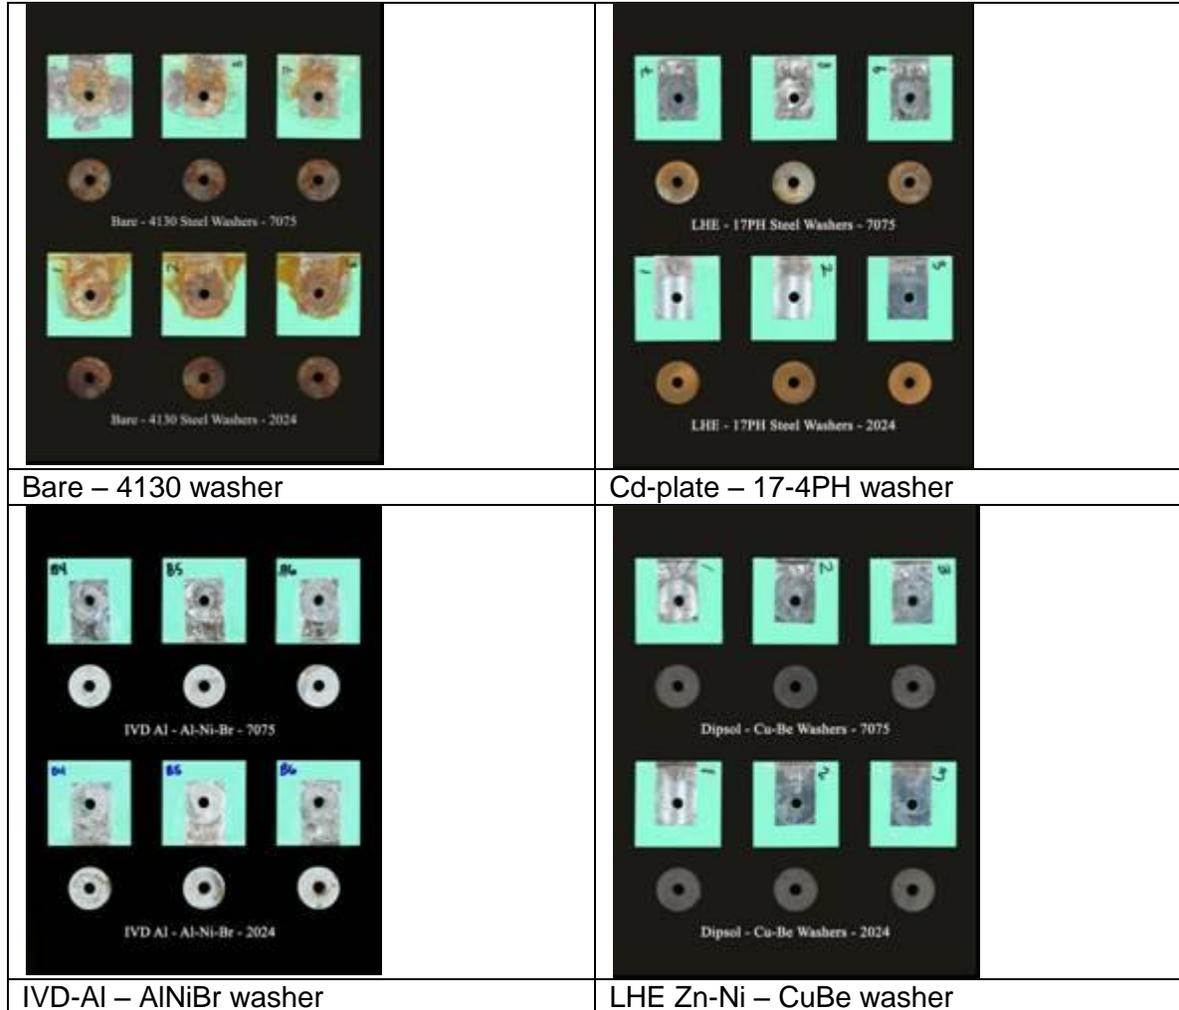
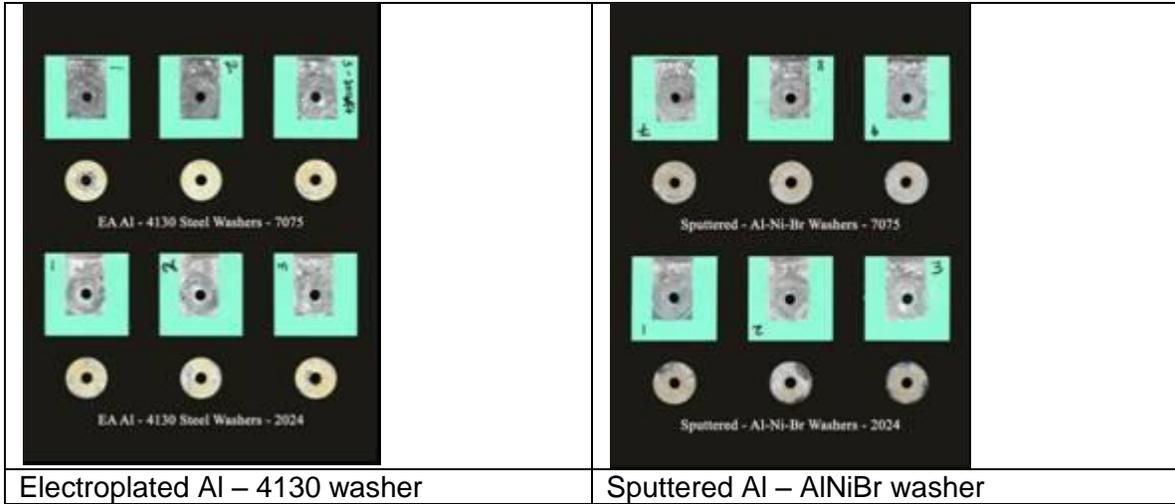
Figure 8. Representative Photos of Salt Spray-Exposed Fixtures

Both the test results and photos indicate that the fixtures performed better in cyclic corrosion than salt spray. In addition, as expected, the bare test washer exhibited the most corrosion and had the largest changes in conductivity. The Cd-plated test washers only showed a conductivity change for the 17-4PH stainless steel substrate in both the salt spray and cyclic corrosion tests. The alternative coating that had the most changes in conductivity upon salt spray exposure was LHE Zn-Ni. This was followed by electroplated Al and sputtered Al, which both had small changes in conductivity for almost every test washer/test block alloy combination. The exception was electroplated Al on CuBe, which had no change in conductivity. All alternatives exhibited little to no change in conductivity for assemblies exposed to cyclic corrosion.

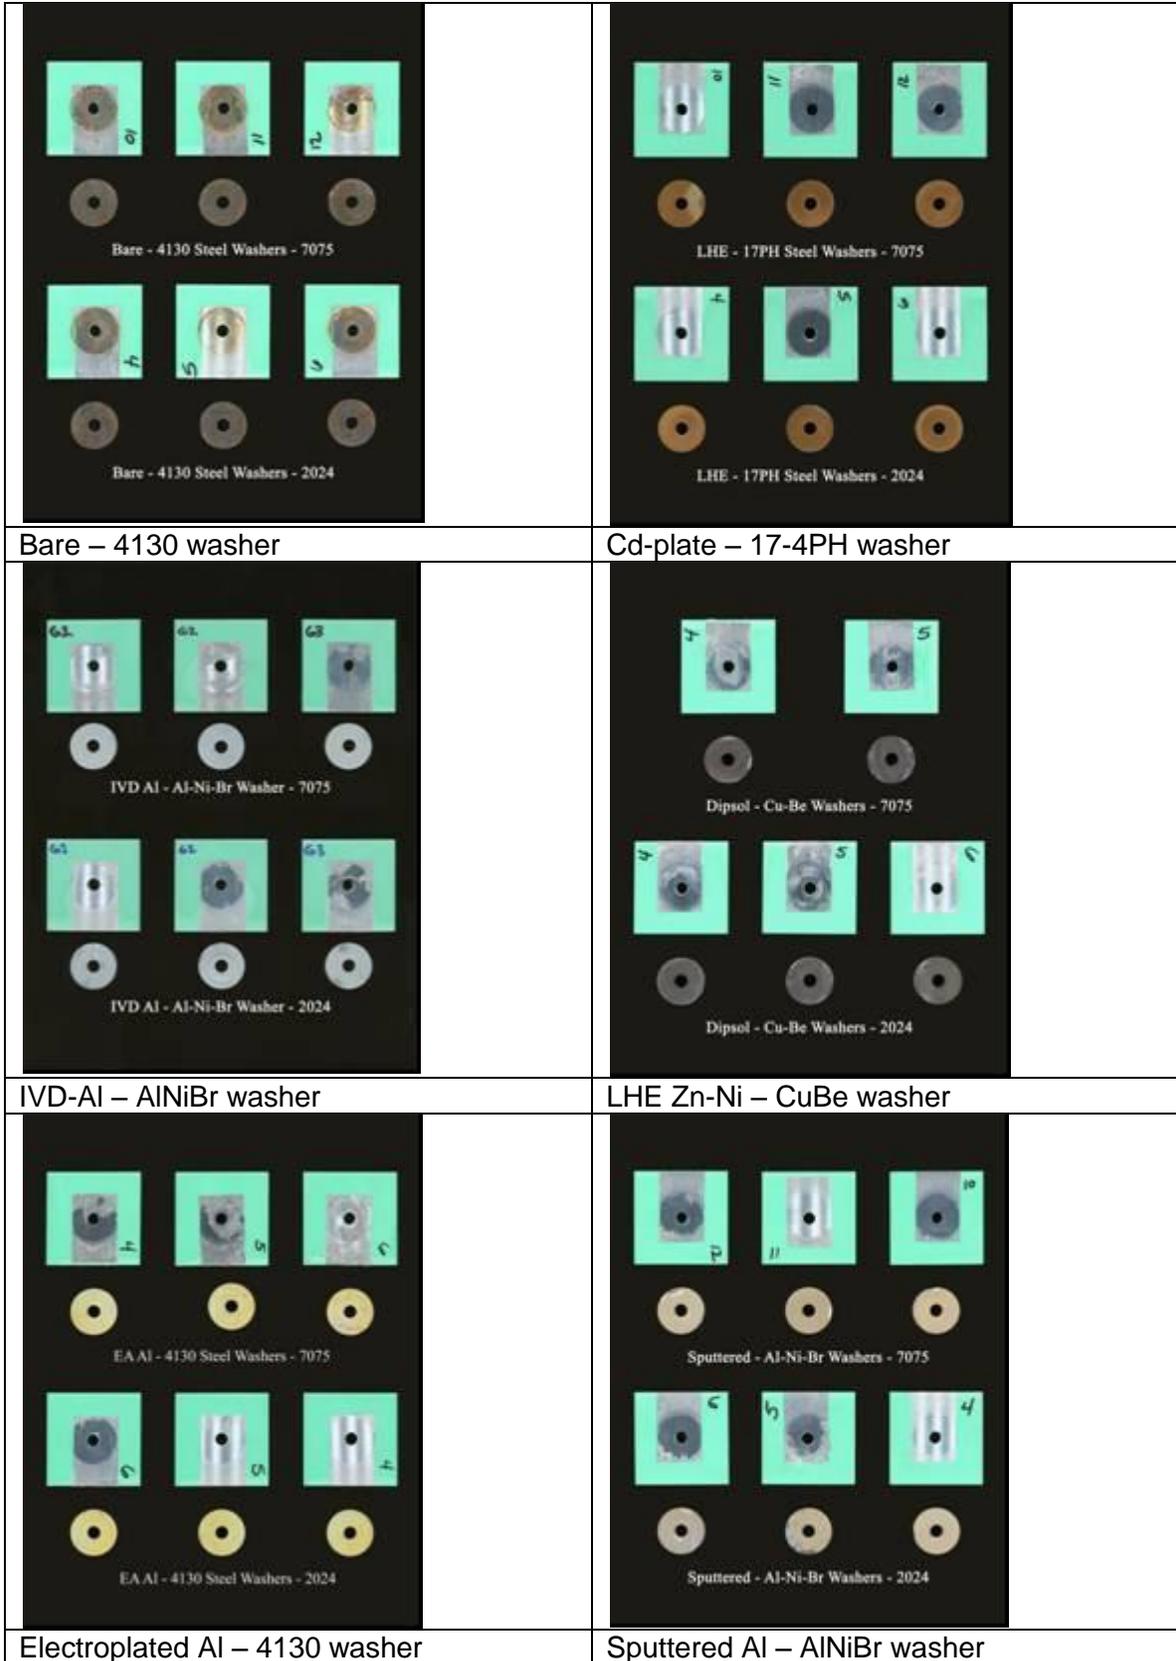
Figure 9. Representative Photos of Cyclic Corrosion-Exposed Fixtures

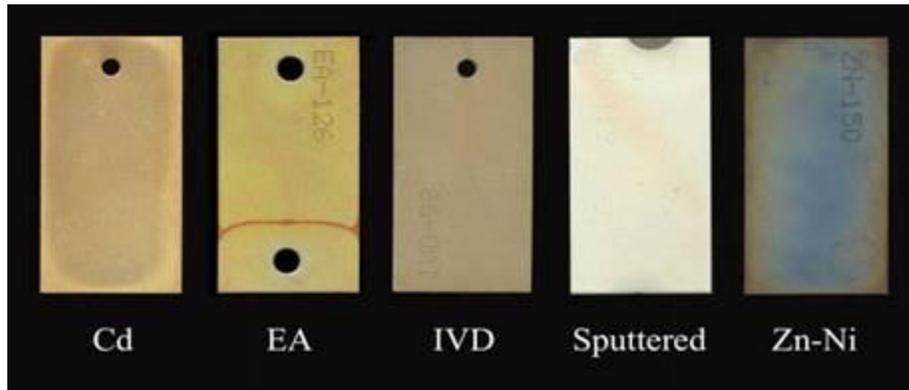
Figure 10. Representative Photo of Coated Panels Prior to Test

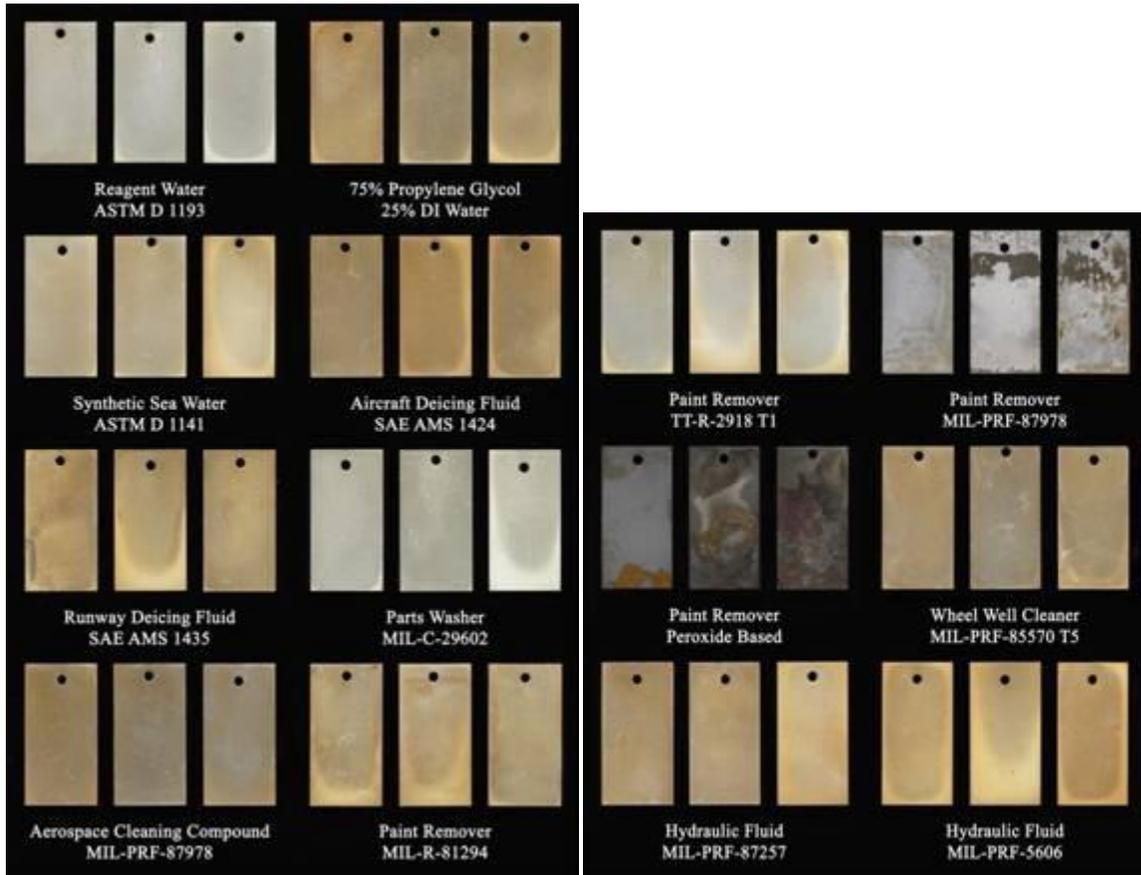
Figure 11. Cd-Plated Panels after Fluid Immersion

discussion following the figures and Table 24 describes how the alternative coatings performed when compared to the acceptance criteria, which states that the alternatives should perform as well as the Cd plated samples as determined by weight loss and appearance. Figures 11 to 15 contain photos of the Cd-plated panels and each alternative after exposure to the test fluids. Table 24 contains the weight loss and appearance results.

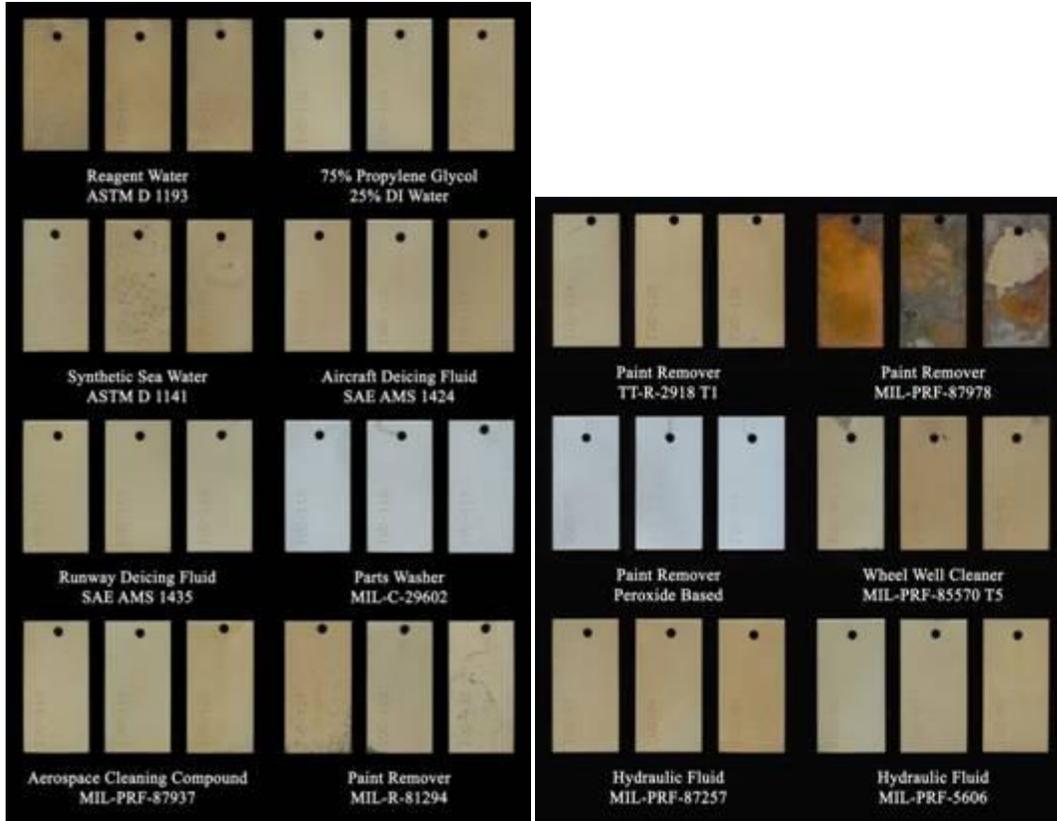
Figure 12. IVD-Aluminum Panels after Fluid Immersion

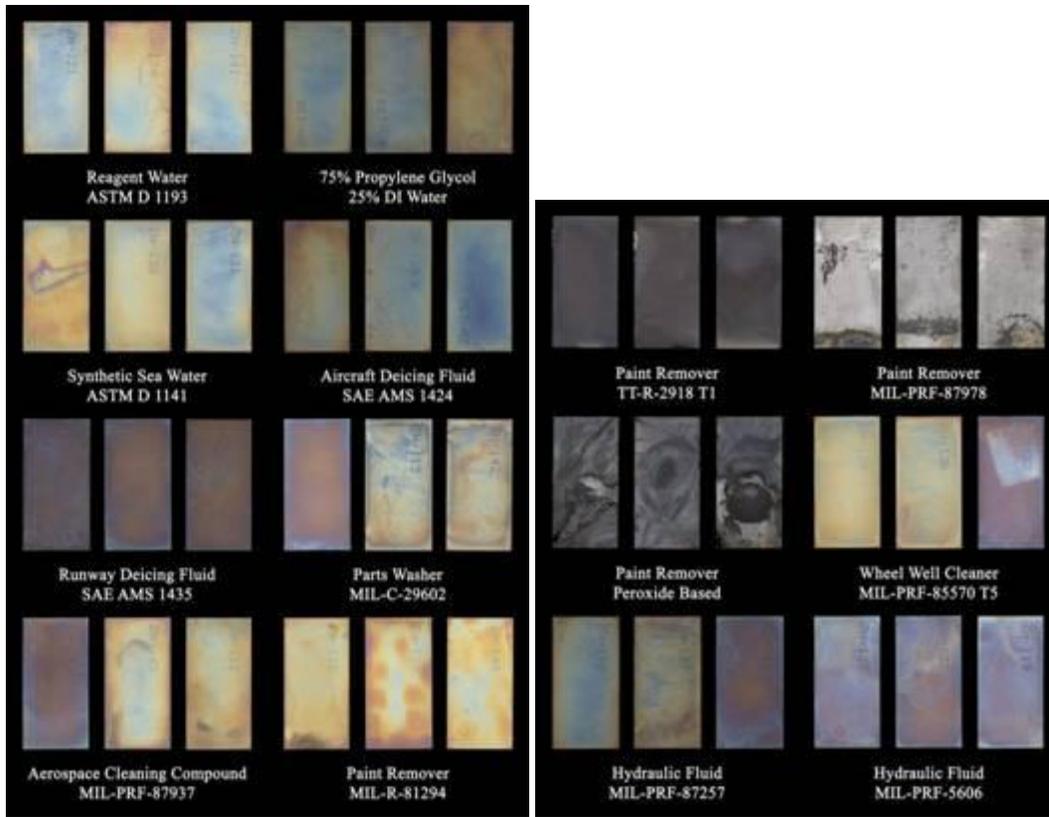
Figure 13. LHE Zn-Ni Panels after Immersion

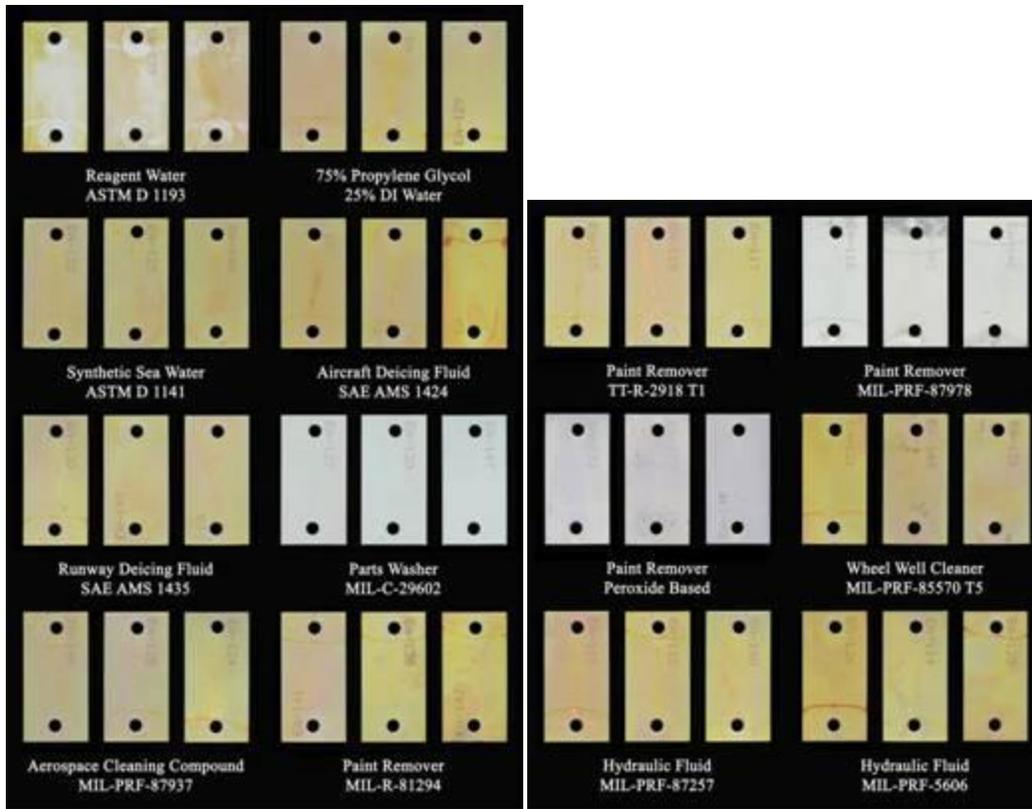
Figure 14. Electroplated Al Panels after Immersion

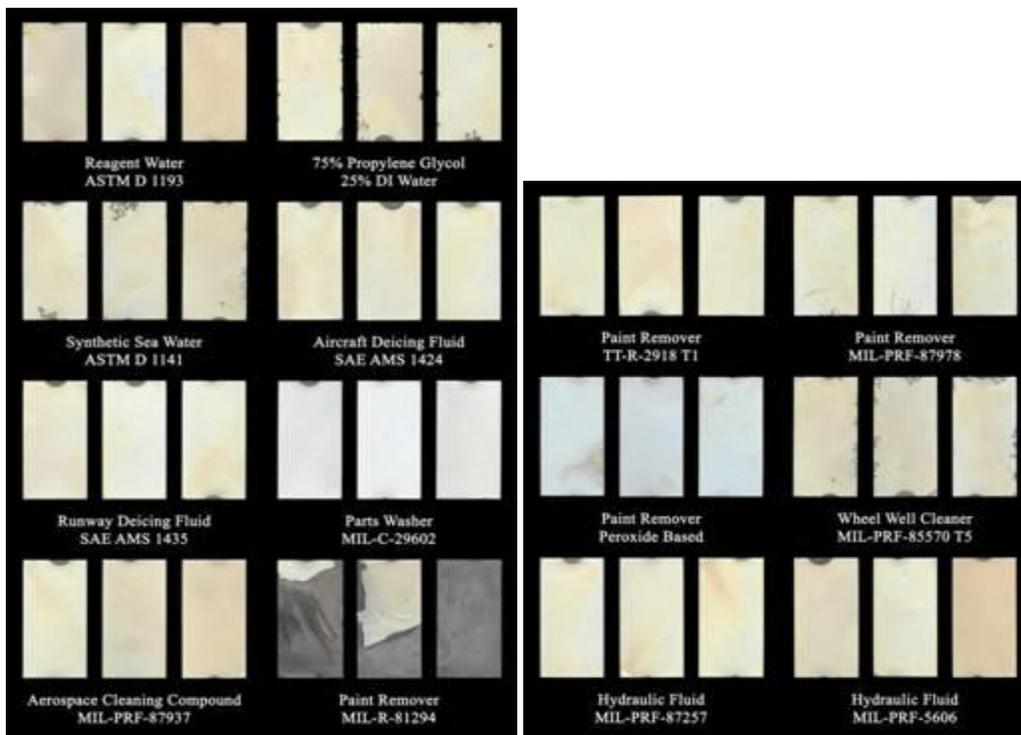
Figure 15. Sputtered Al Panels after Immersion

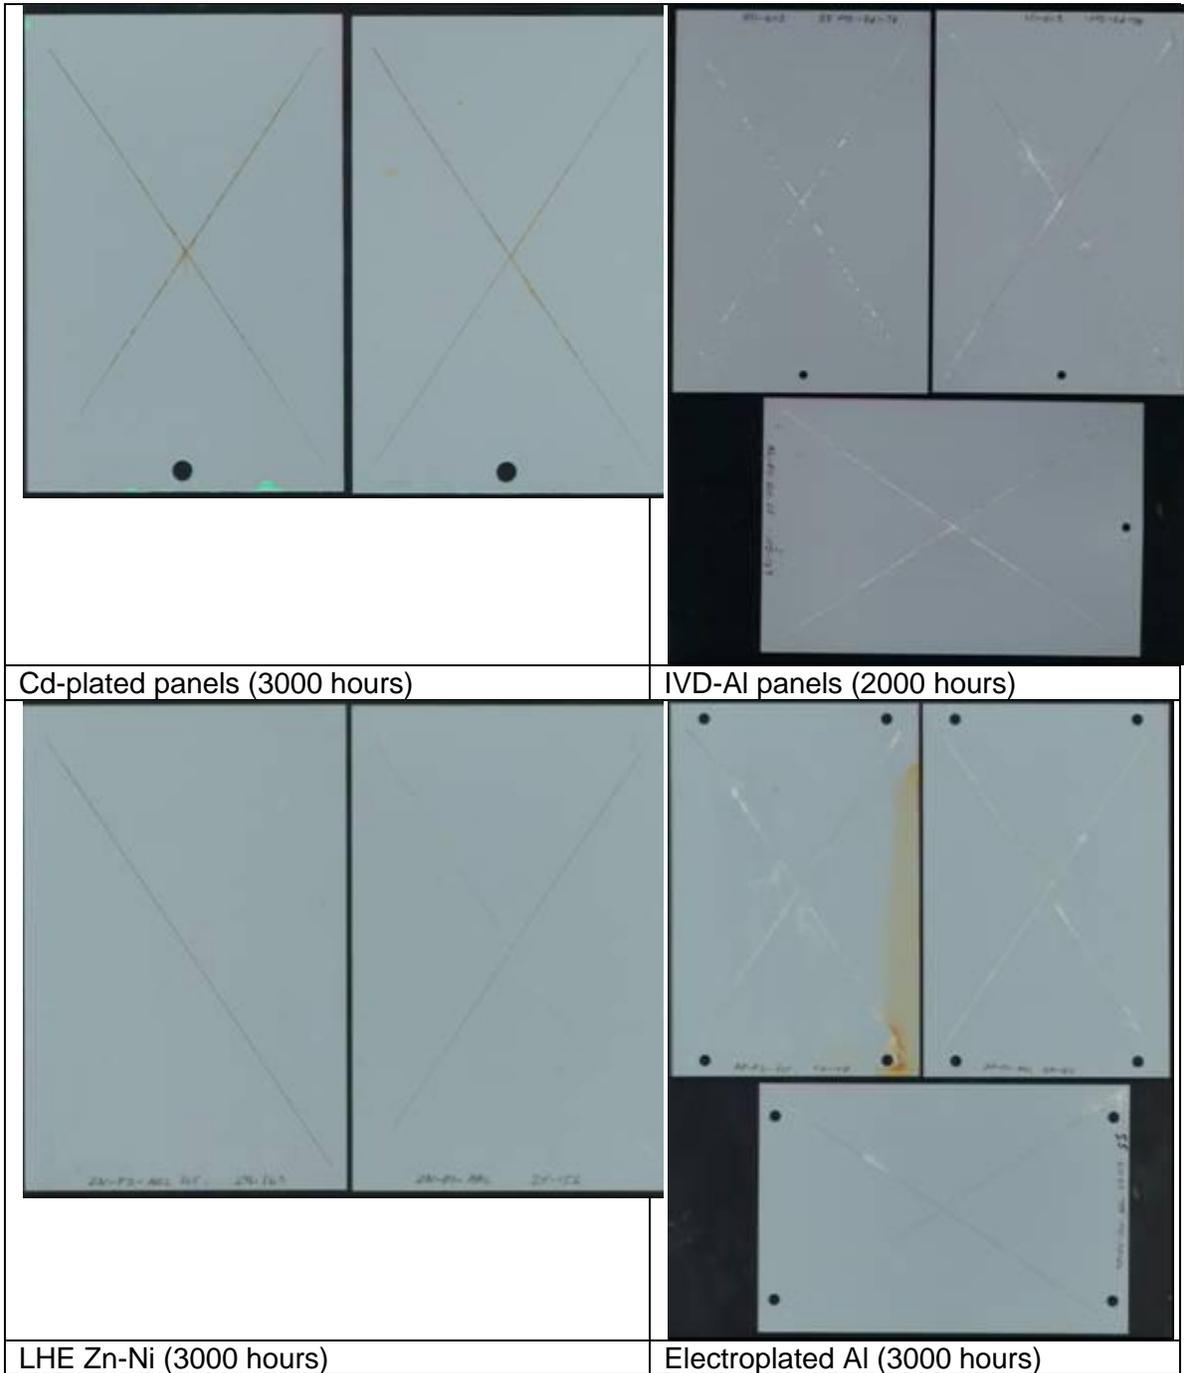
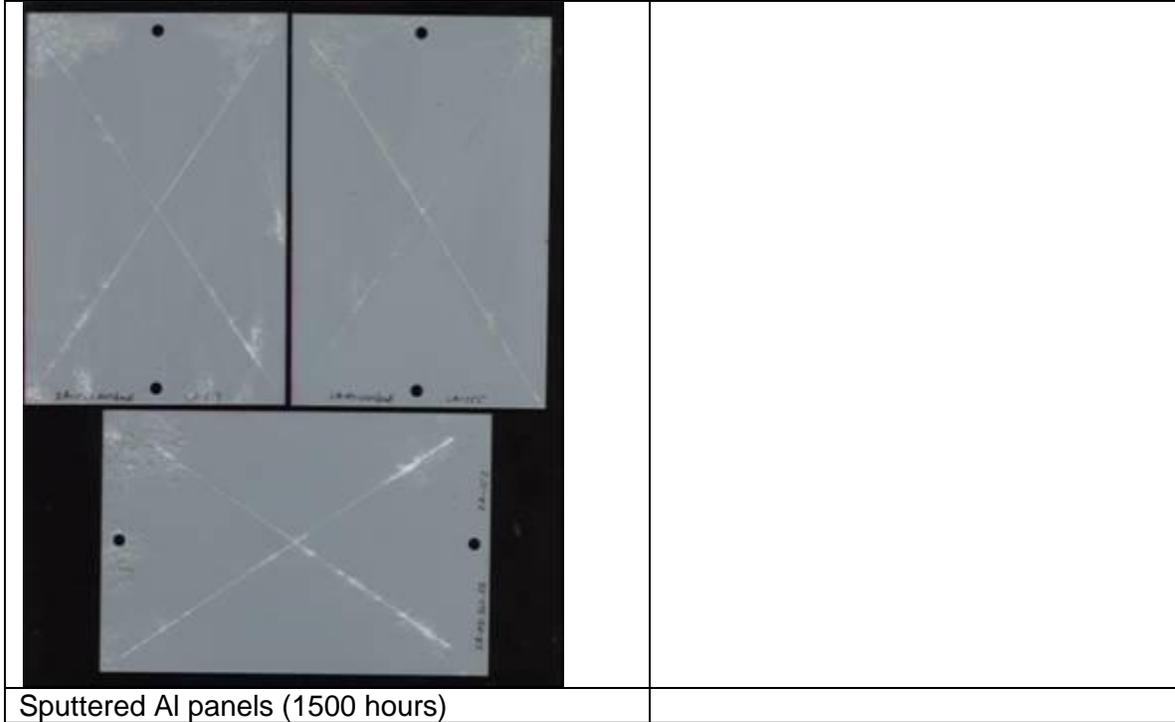
Figure 16. Representative Painted and Scribed Corrosion Resistance Panels

remained exposed for 3000 hours and received a “4” rating, based on the length of creepage from the scribe. Otherwise, it does not appear that any particular primer performed better or provided more corrosion resistance.

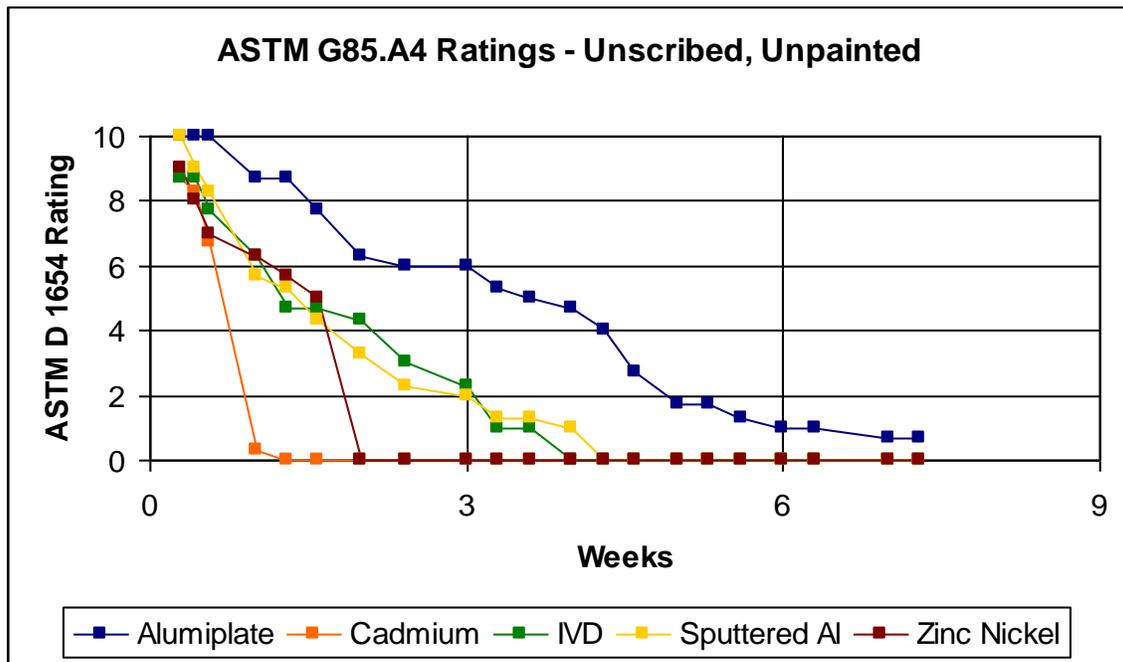
The graph in Figure 17 shows how the ratings by visual examination of the panels in the chamber changed over time. From the graph, it is very clear that all coatings performed at least two times better than Cd, with the Al coatings also performing better than LHE Zn-Ni. Figure 18 contains representative photos of each of the coatings at the given exposure times.

Figure 17. Graph of Ratings for SO₂ Corrosion Resistance – Unscribed Panels

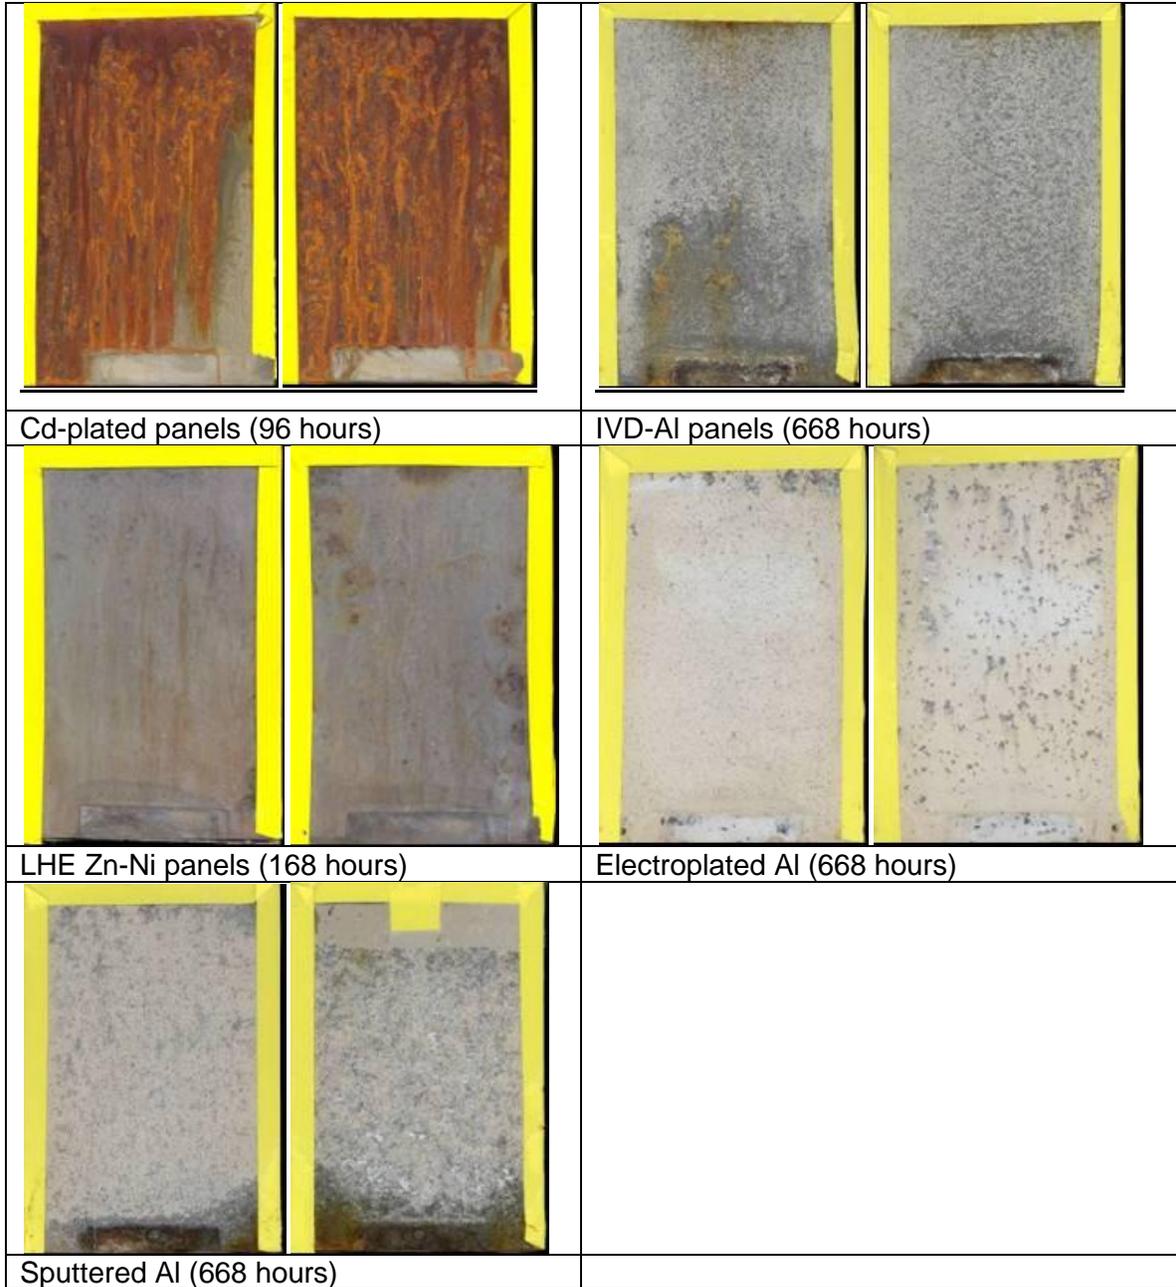
Figure 18. Representative Photos of SO₂ Salt Fog-Exposed Panels

In the acidified salt fog environment (ASTM G85, Annex 4), the Al coatings generally performed best. In the unscrubbed condition, Cd failed significantly in four days (96 hour). The LHE Zn-Ni coating performed better than Cd in this study; however, some red rust was apparent after one week. After two weeks, the Zn-Ni looked similar to Cd after one week (i.e. mostly corroded), and hence performed about twice as well as Cd in this environment. IVD-Al exhibited red rust on one of three panels prior to the 3 week (500 hour) inspection, and is shown at the 4 week (668 hour) inspection in Figure 18. For this part of the testing (SO₂ salt fog), the IVD-Al panels had been provided by Navy Fleet Readiness Center Southwest. The electroplated Al coating had the best appearance of the alternatives when evaluated after 668 hours, where two of three panels were

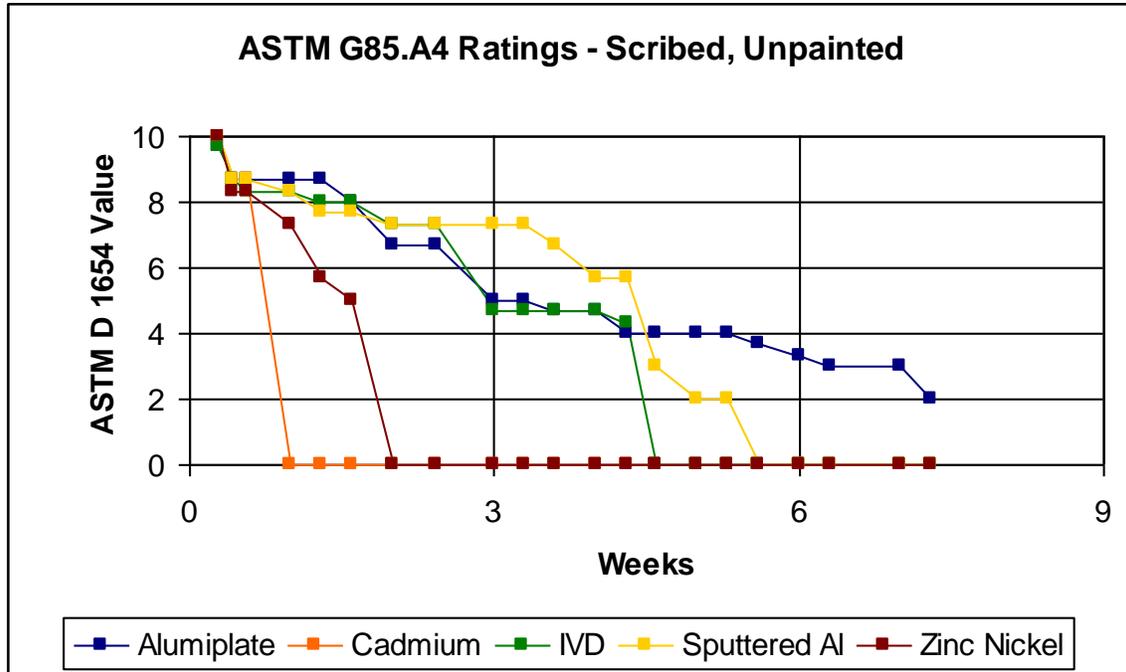
Figure 19 contains a graph of the results of SO₂ corrosion resistance for the scribed panels, which are very similar to the results seen for the unscribed panels, with all alternative coatings performing better than the Cd-plated panels. Figure 20 contains representative photos of the panels at the exposure times listed in the figure.

Figure 19. Graph of Ratings for SO₂ Corrosion Resistance – Scribed Panels

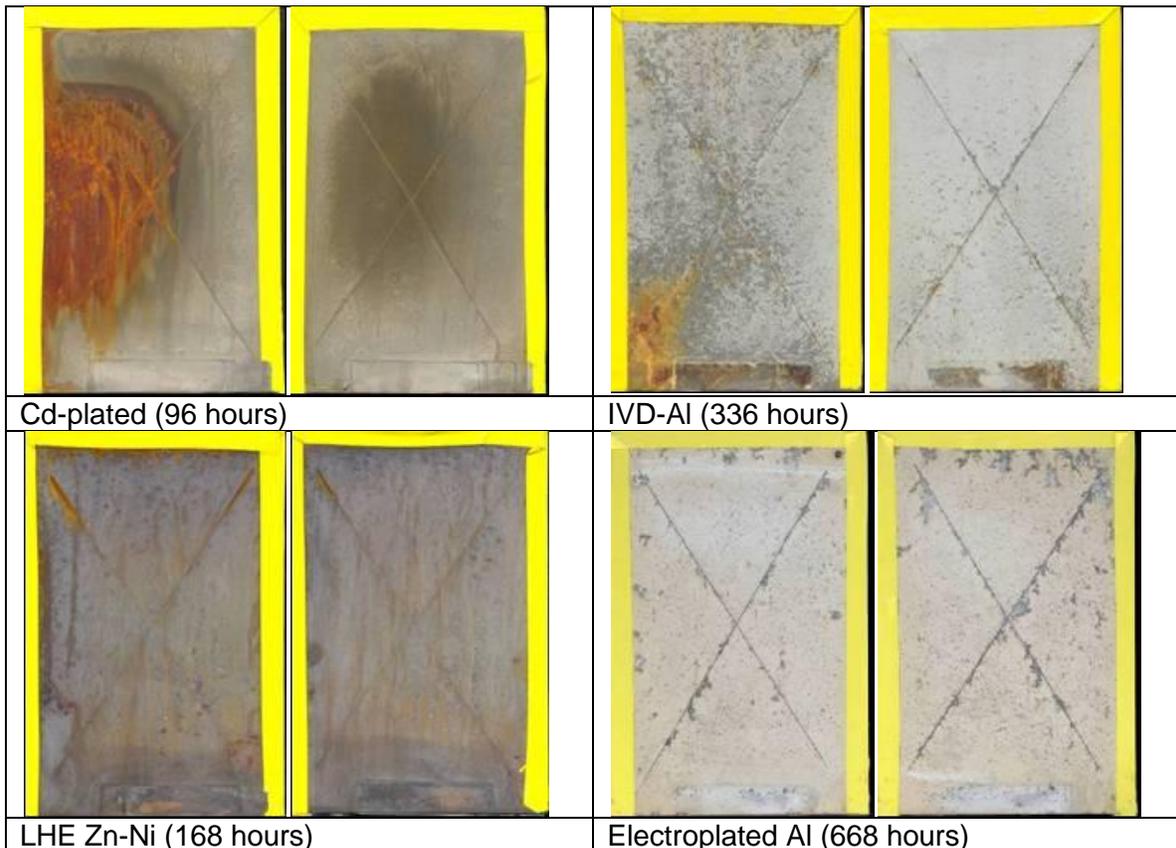
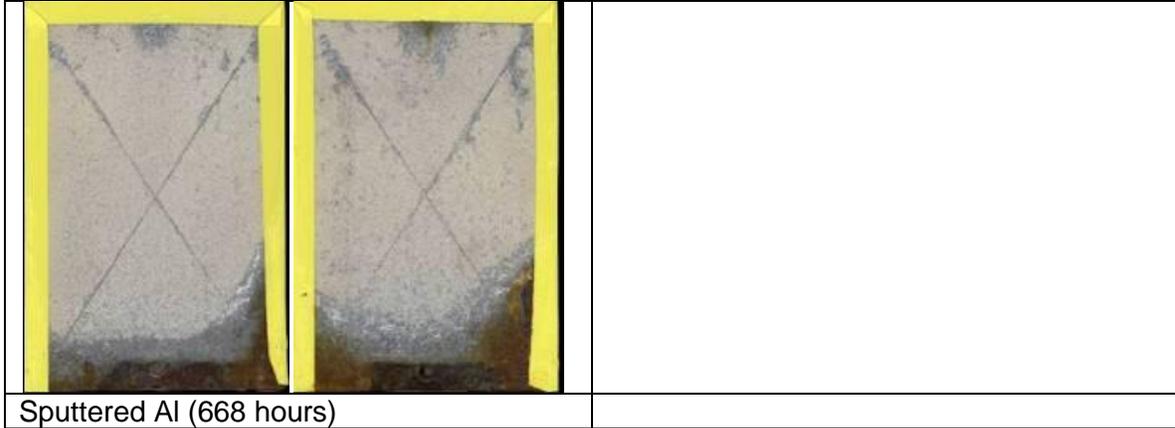
Figure 20. Representative Photos of SO₂ Salt Fog-Exposed Scribed Panels
