**Weapon System Technical, Logistical, and Sustainment Support
FA8601-05F-0011**

**Subtask 024: Testing Cadmium Alternatives for High
Strength Steel: Phases II and III Testing**

**Testing Cadmium Alternatives for High Strength Steel Phase
II Joint Test Report**

November 23, 2009

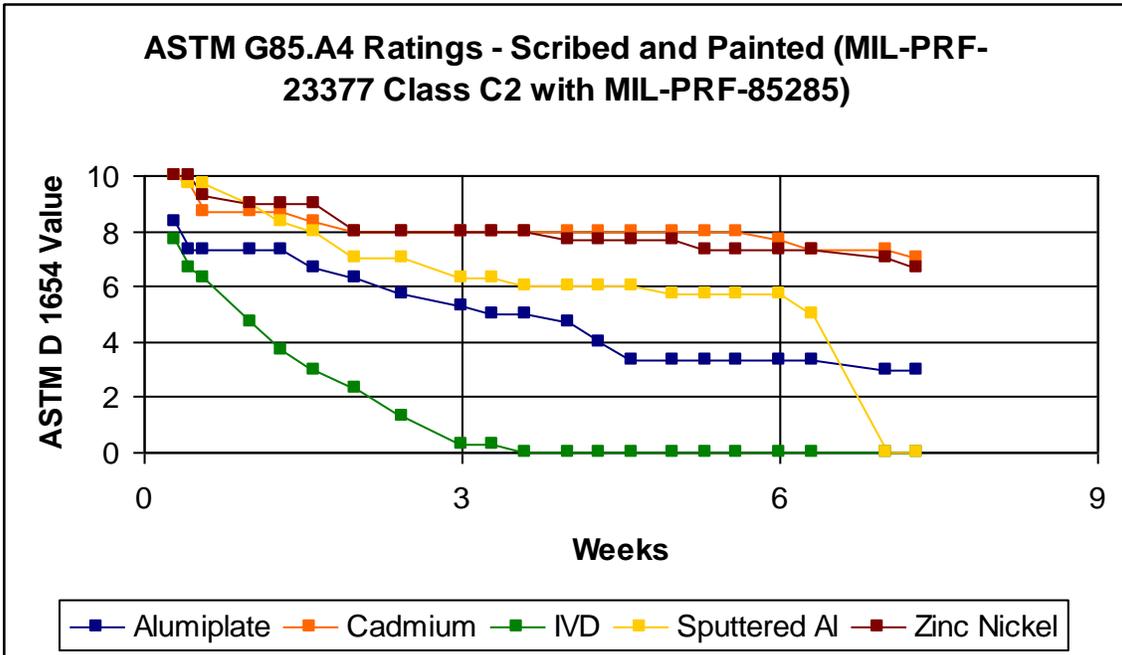
Figure 21. Graph of Ratings for SO₂ Corrosion Resistance – Panels Painted with MIL-PRF-23377 Class C2

Figures 21, 22, and 23 contain graphs of the SO₂ corrosion resistance results for each primer tested. Overall, the best protection from red rust at the scribes was provided by the Al coatings, as would be expected from the bare coating results presented earlier. However, even though there was little to no red rust observed throughout the duration of the test, significant field blistering and adhesion issues were noted as the test progressed. Figure 24 contains representative photos of the test panels.

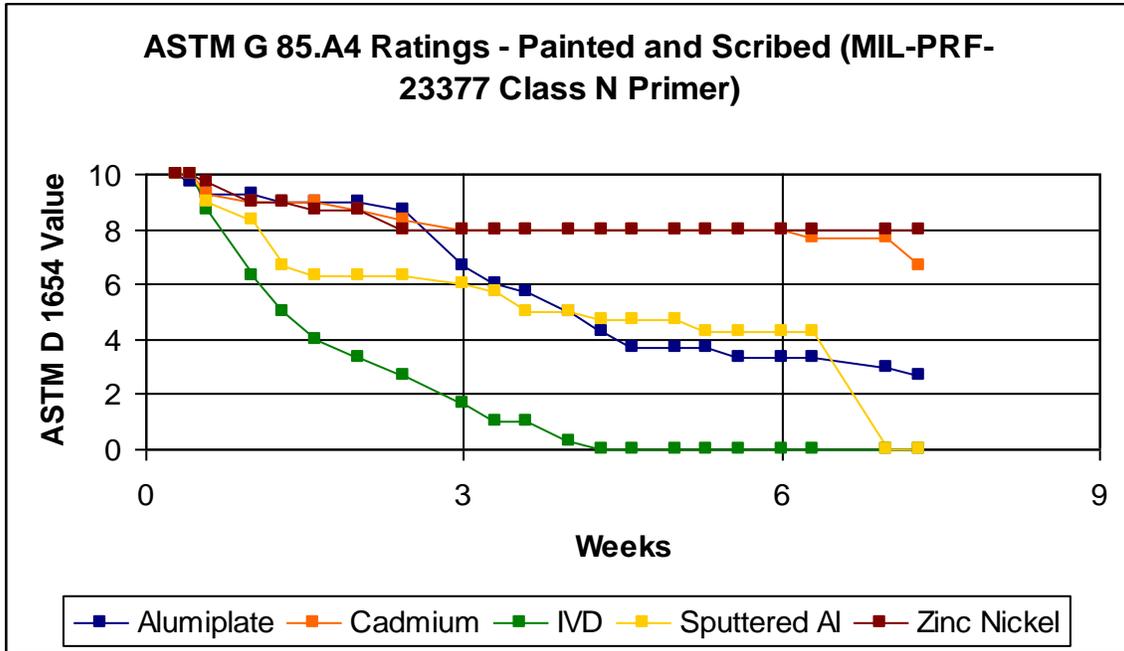
Figure 22. Graph of Ratings for SO₂ Corrosion Resistance – Panels Painted with MIL-PRF-23377 Class N

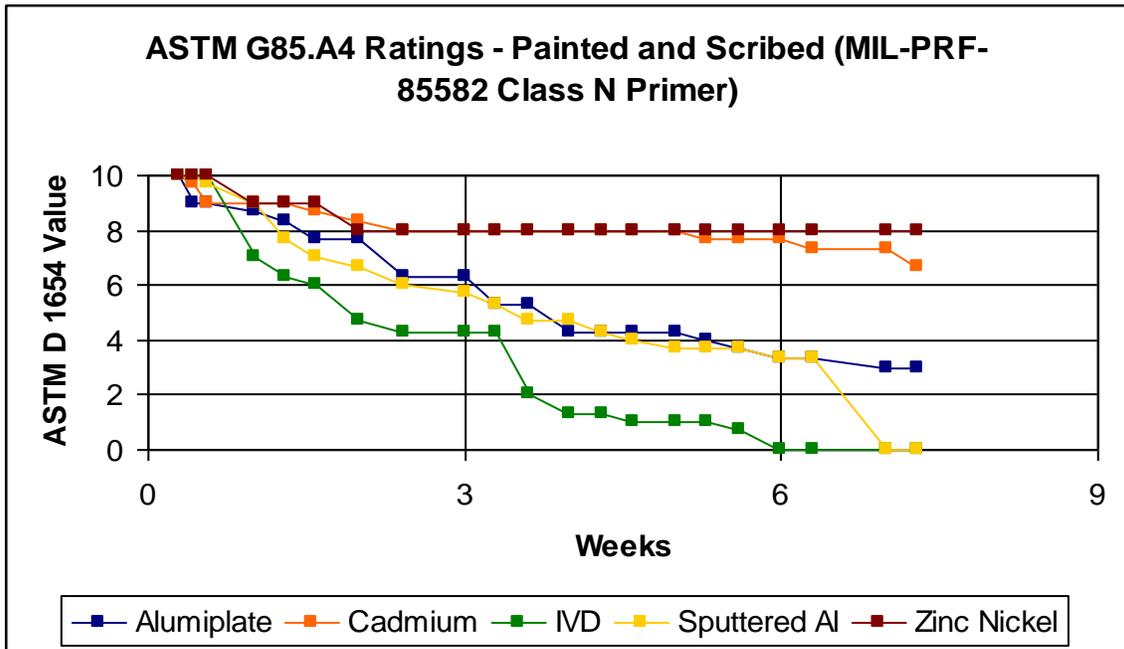
Figure 23. Graph of Ratings for SO₂ Corrosion Resistance – Panels Painted with MIL-PRF-85582 Class N

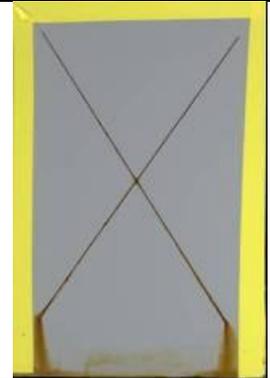
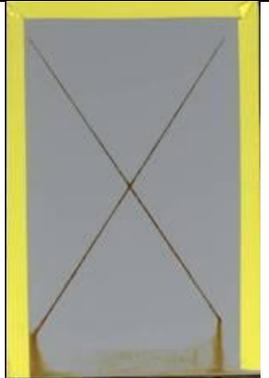
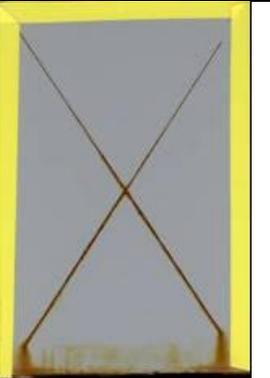
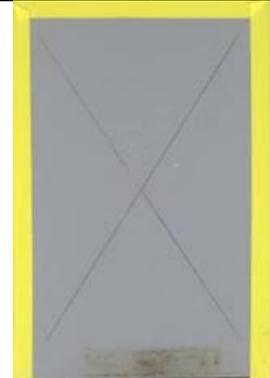
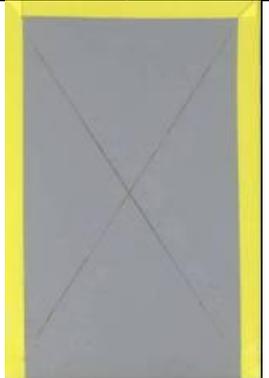
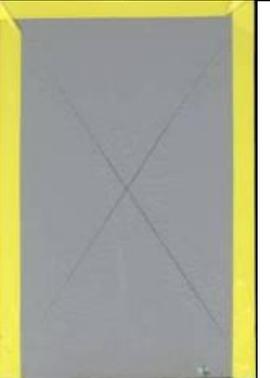
| Cd plating with MIL-PRF-23377 C2 (1168 hours) | Cd plating with MIL-PRF-23377 N (1168 hours) | Cd plating with MIL-PRF-85582 N (1168 hours) |
| IVD-AI with MIL-PRF-23377 C2 (500 hours) | IVD-AI with MIL-PRF-23377 N (668 hours) | IVD-AI with MIL-PRF-85582 N (840 hours) |

Figure 24. Representative Photos of SO₂ Salt Fog-Exposed Painted Scribed Panels

Results of this accelerated corrosion test are influenced by the quality of the conversion coating applied by the coating vendors. In the case of the sputtered Al, the panels arrived at NAVAIR, Patuxent River for test in the non-conversion coated condition since the vendor did not have this capability. A fresh chromate conversion coating was applied the day prior to the primer application, so time-to-paint was not a factor for the observed paint adhesion failure on Sputtered Al. All panels were shipped by the vendors in a fairly tightly wrapped condition, and they were unpacked the day prior to primer application to ensure the surfaces remained clean.

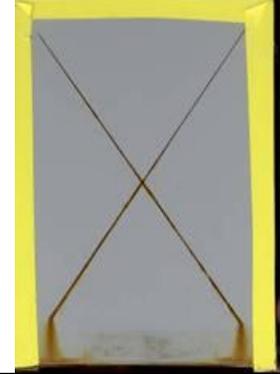
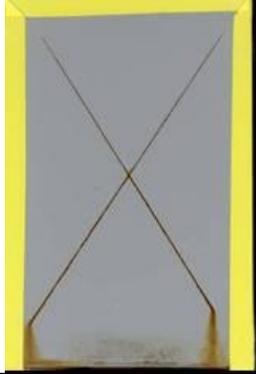
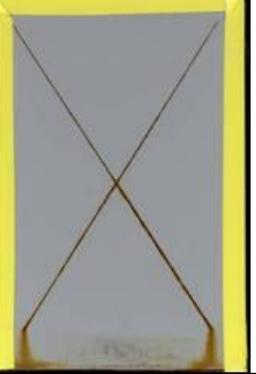
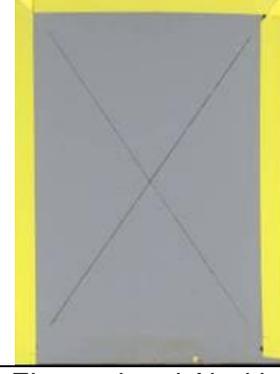
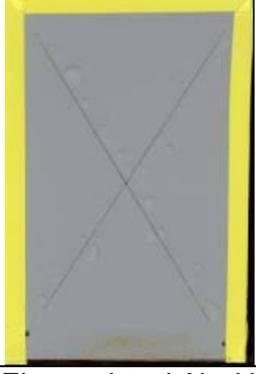
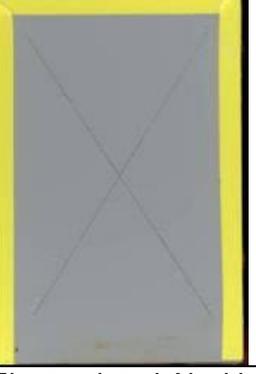
| LHE Zn-Ni with MIL-PRF-23377 C2 (1168 hours) | LHE Zn-Ni with MIL-PRF-23377 N (1168 hours) | LHE Zn-Ni with MIL-PRF-85582 N (1168 hours) |
| Electroplated Al with MIL-PRF-23377 C2 (1168 hours) | Electroplated Al with MIL-PRF-23377 N (1168 hours) | Electroplated Al with MIL-PRF-85582 N (1168 hours) |

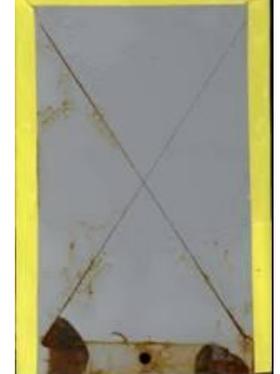
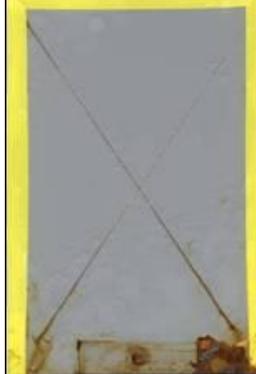
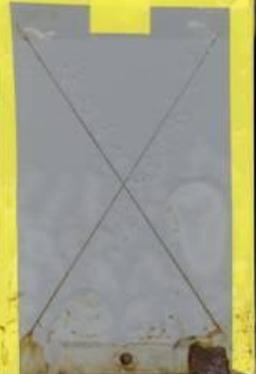
| Sputtered Al with MIL-PRF-23377 C2 (1168 hours) | Sputtered Al with MIL-PRF-23377 N (1168 hours) | Sputtered Al with MIL-PRF-85582 N (1168 hours) |

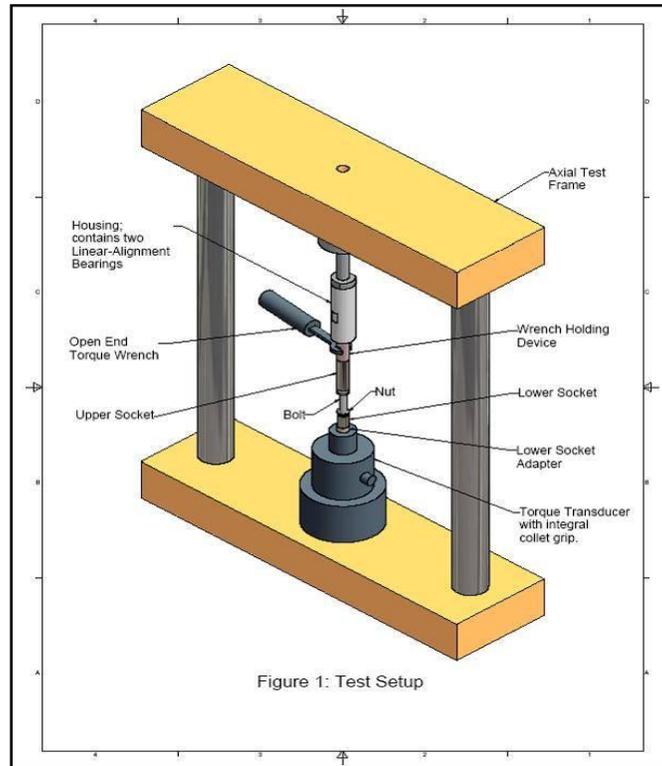
The breakaway torque was then measured during removal of the nut from the clamped up threaded part. The nut was removed from the test bolt between each cycle. In addition, any loosened particles were blown off with compressed air, if necessary, before continuing. The locking and breakaway torque was measured for 15 lock/breakaway cycles and at completion of the testing, the nut and bolt were examined for thread damage at ten (10) times magnification.

Figure 25. Maximum Locking Torque and Breakaway Torque Test Setup

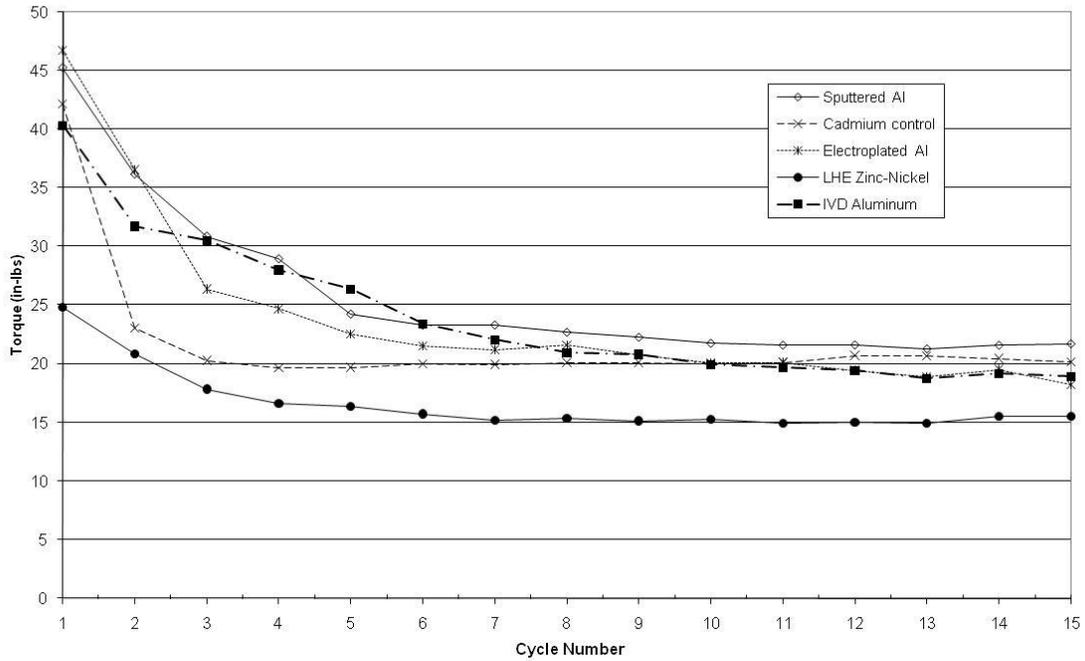
Figure 26. Graph of Maximum Locking Torque for the 3/8-inch Fasteners

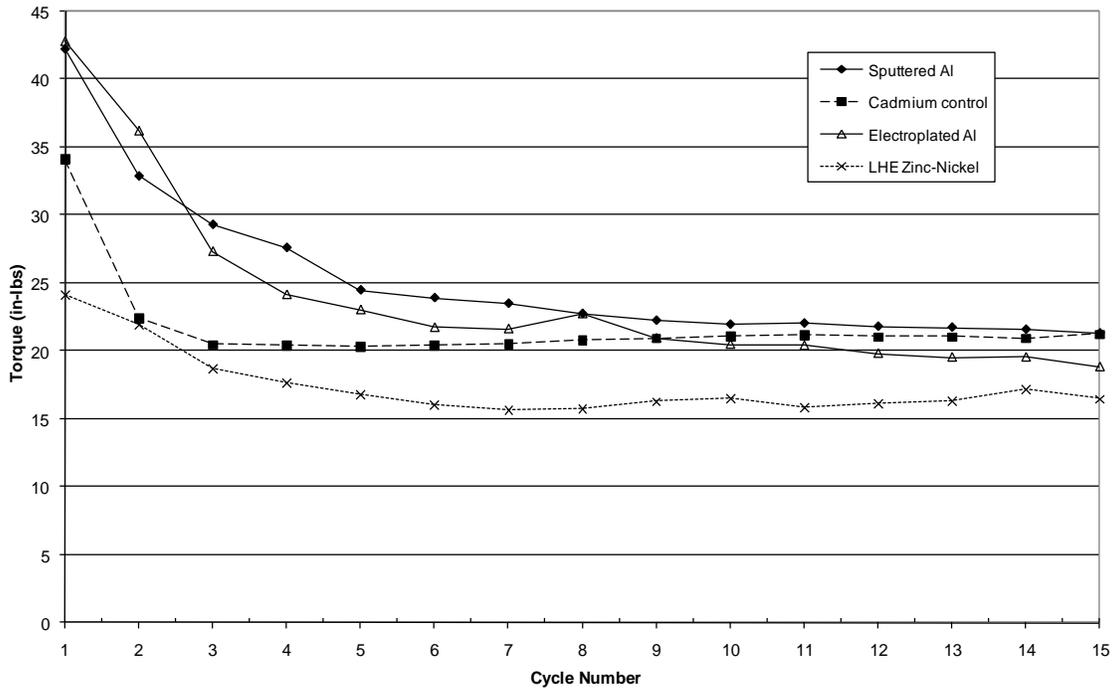
Figure 27. Graph of Breakaway Torque for 3/8-inch Fasteners

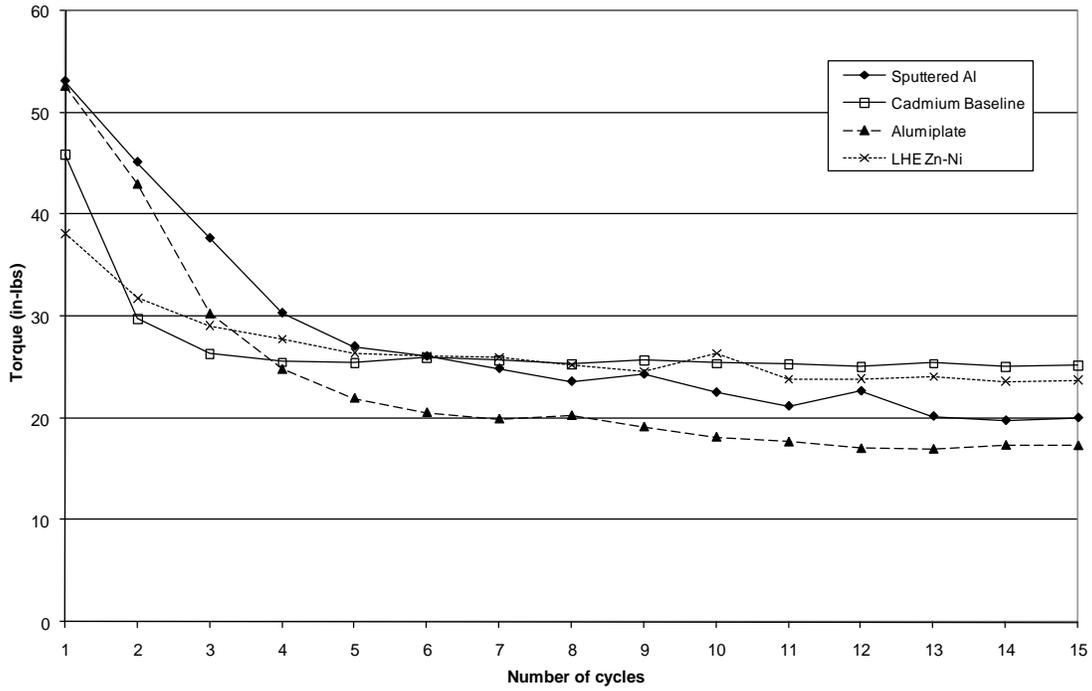
Figure 28. Graph of Maximum Locking Torque for 5/8-inch Fasteners

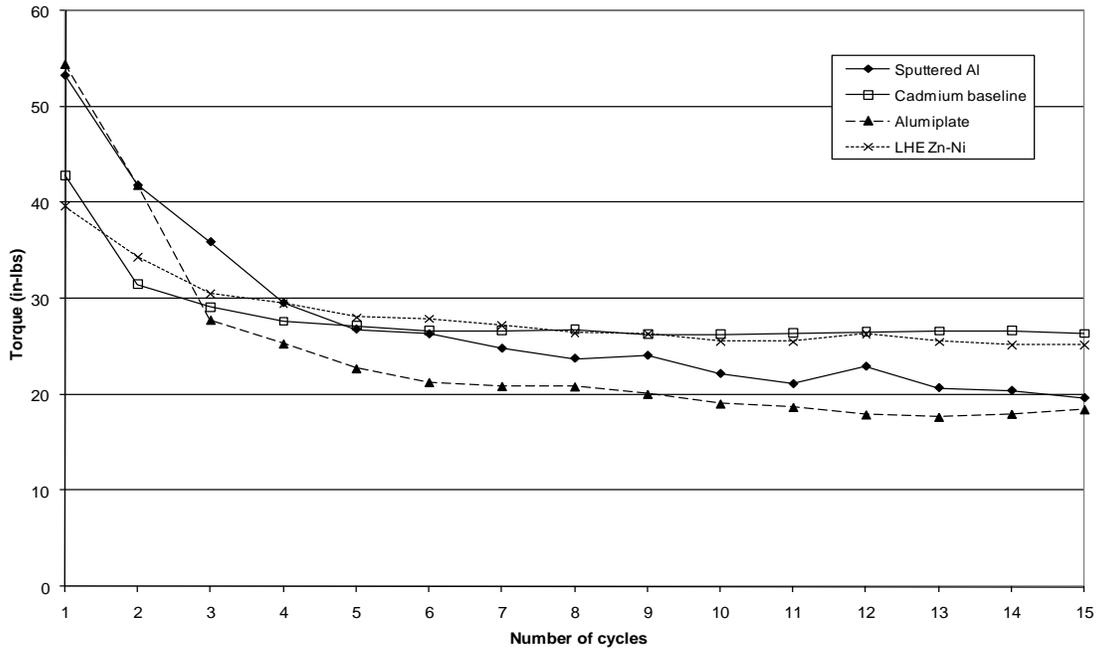
Figure 29. Graph of Breakaway Torque for 5/8-inch Fasteners

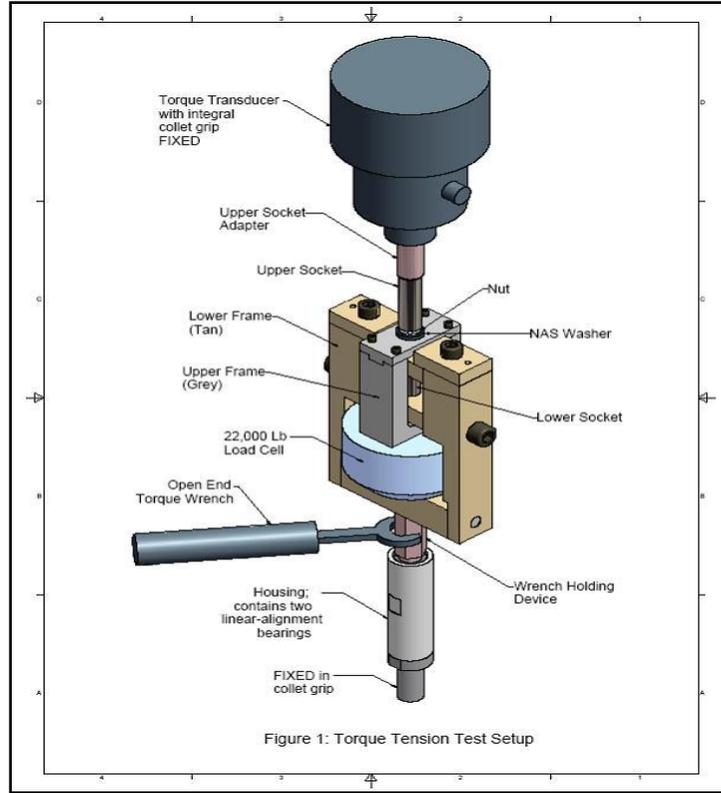
The coating was applied as recommended by the manufacturer, to the same thickness class as the original coatings. A representative test fixture to measure torque-tension is shown in Figure 30. The test nut, bolt, and washers were tested with SAE AMS 2518 (*Thread Compound, Anti-Seize, Graphite-Petrolatum*, revised July 2001).

Figure 30. Representative Torque Tension Test Fixture

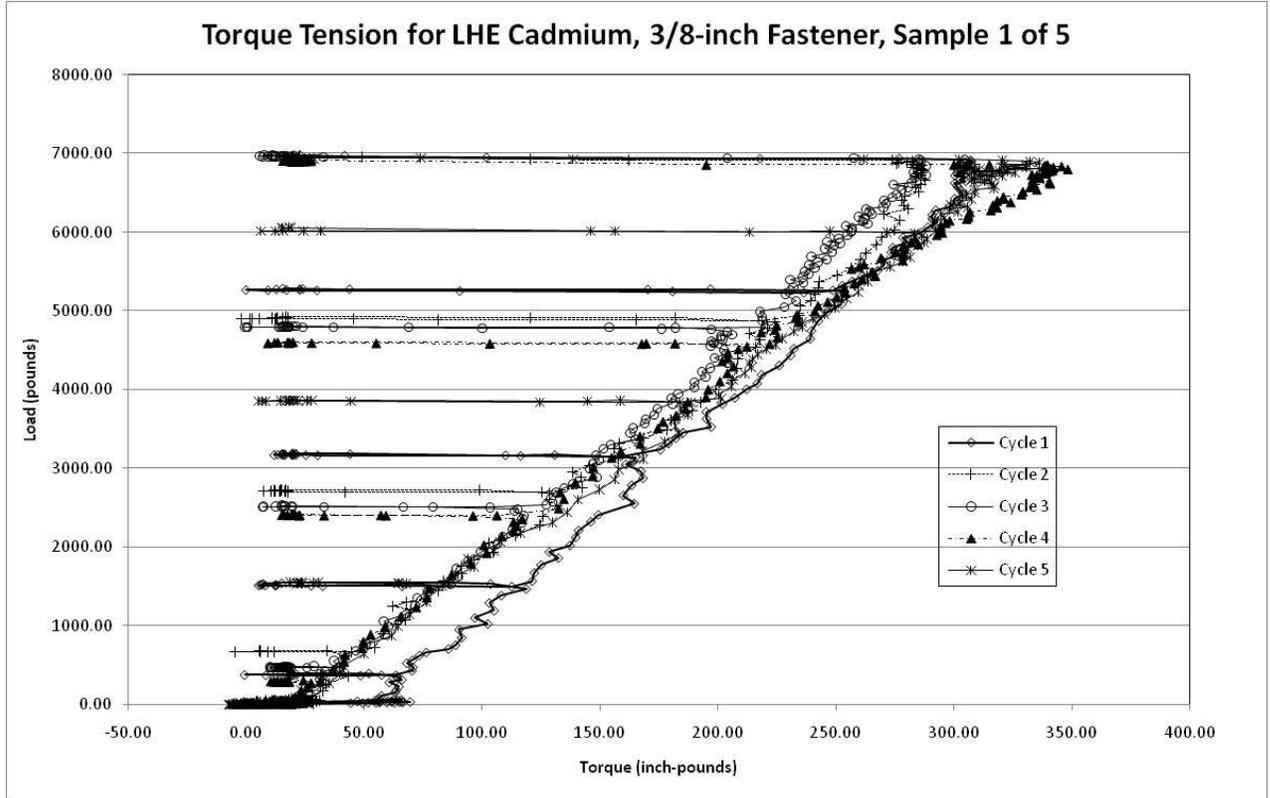
Figure 31. Torque Tension Results for LHE Cd, 3/8-inch Fastener

Representative graphs are listed as Figures 31 through 34 for the torque tension, load versus torque curves for the 3/8-inch fasteners. Each graph contains data for 5 cycles of loading and then completely removing the nut. Visual observation provided by WMTR was that there was no loose/peeling coating or stripping of the threads on the bolts during testing.

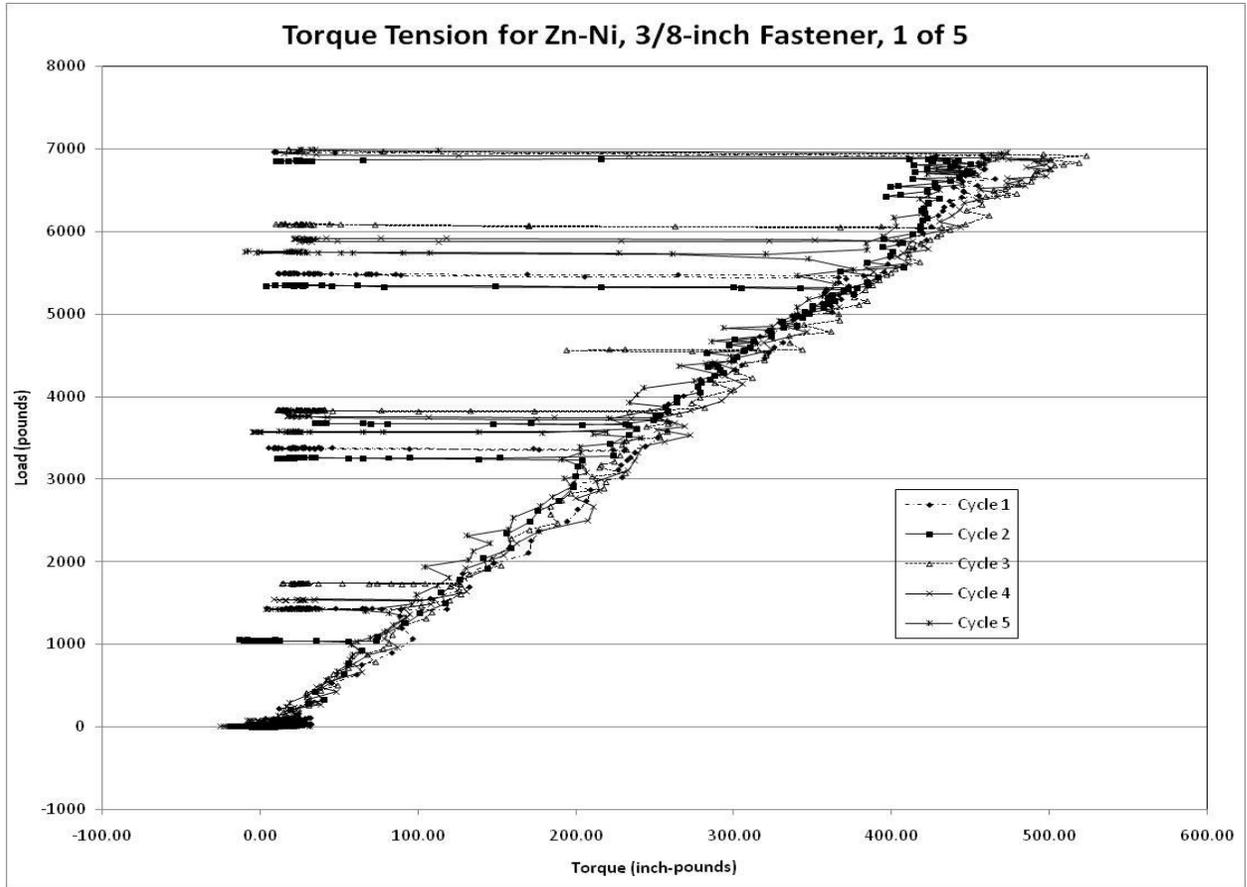
Figure 32. Torque Tension Results for Zn-Ni Coated 3/8-inch Fasteners

The Zn-Ni results are similar to LHE Cd, with little variance in torque values from Cycle 1 to Cycle 5. The maximum torque values were slightly higher than Cd, ranging from approximately 400 - 500 in-lbs, compared to 275 – 350 in-lbs for Cd. Figure 33 contains the curves for electroplated Al on 3/8-inch fasteners.

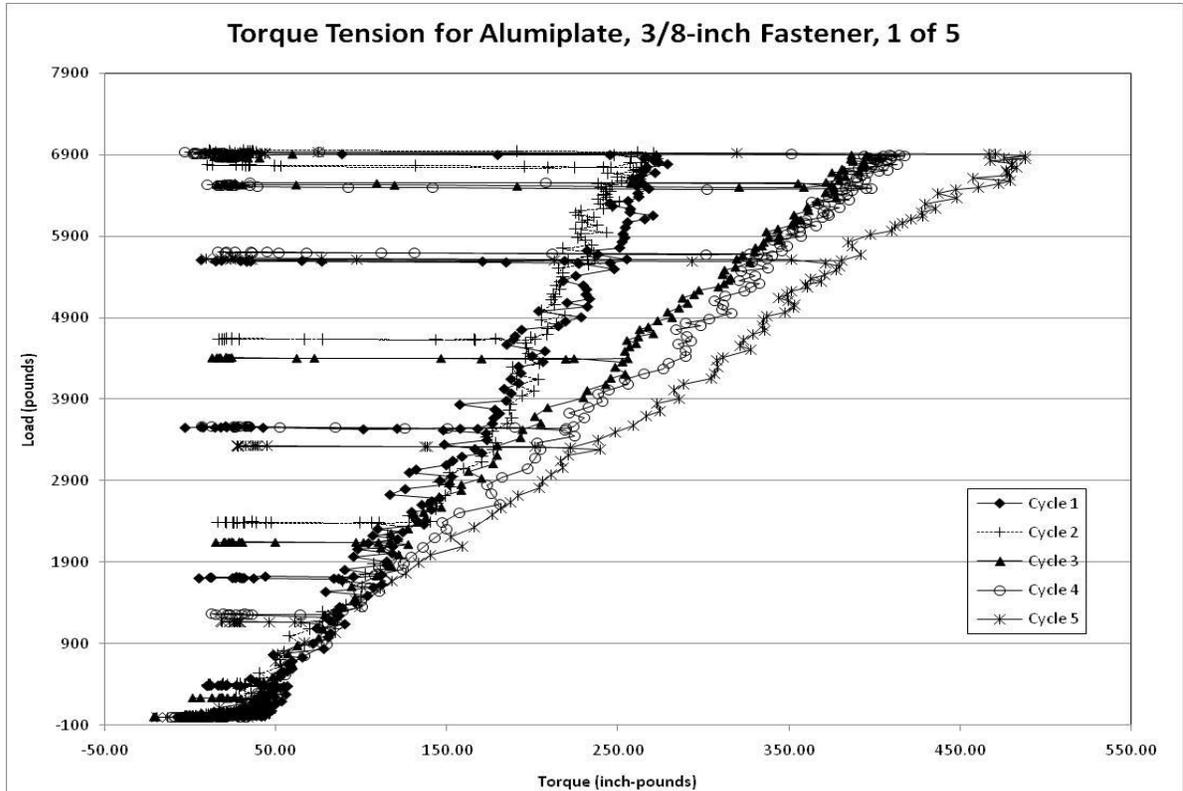
Figure 33. Torque Tension Results for 3/8-inch Fasteners Coated with Electroplated Al

For the electroplated Al samples, the torque values increased with the additional cycles, indicating that the electroplated Al actually increases in lubricity through wear. Again, all curve are relatively linear during the loading cycle. Figure 34 shows the results for sputtered Al-coated 3/8-inch fasteners.

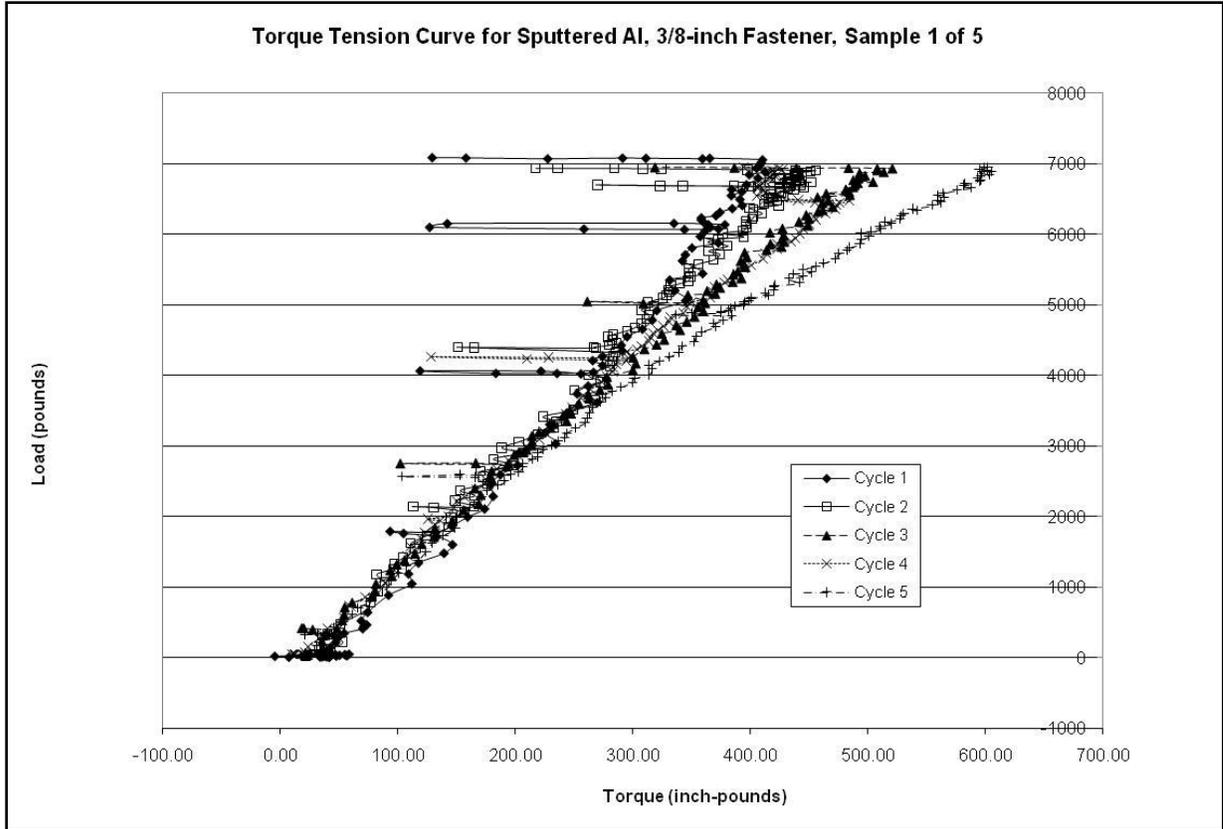
Figure 34. Torque Tension Results for 3/8-inch Fasteners Coated with Sputtered Al

The curves for sputtered Al show the same trend as the electroplated Al, with torque values increasing during loading from Cycle 1 to Cycle 5. The maximum torque values achieved for sputtered Al are slightly higher than electroplated Al, ranging from 350 – 600 in-lbs, as opposed to 200 – 475 in-lbs for electroplated Al. The next series of graphs (Figures 35 – 38) represent the results achieved for the 5/8-inch fasteners. The results for LHE Cd are listed in Figure 35.

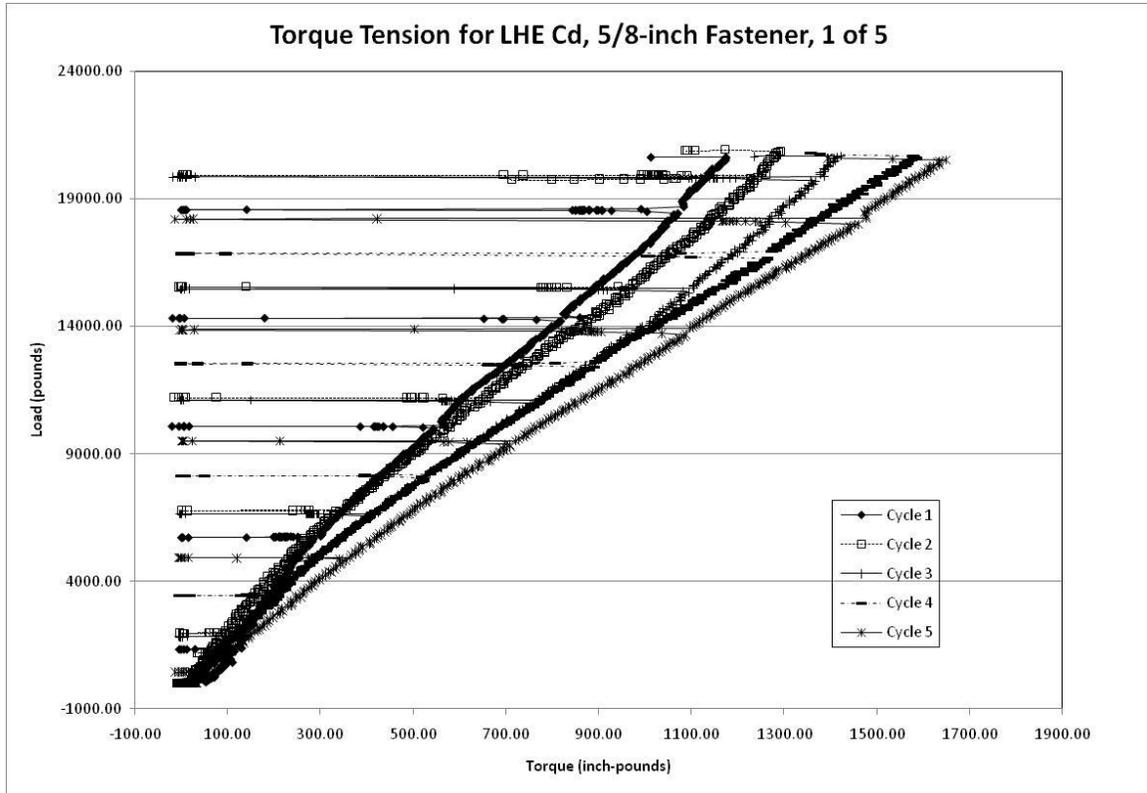
Figure 35. Torque Tension Results for LHE Cd-coated 5/8-inch Fastener

The results for the 5/8-inch fastener coated with Cd show a self-lubricating trend, where the load versus torque curves increase over the cycles. Again, as with the 3/8-inch fasteners, the 5/8-inch fasteners coated with IVD-AI were tested at a later date, and WMTR generated the curves, located in Appendix B. The trend was the same as the 3/8-inch fasteners, with a decrease in torque versus load from Cycle 1 to Cycle 5. Figure 36 contains a representative graph for the Zn-Ni coated fasteners.

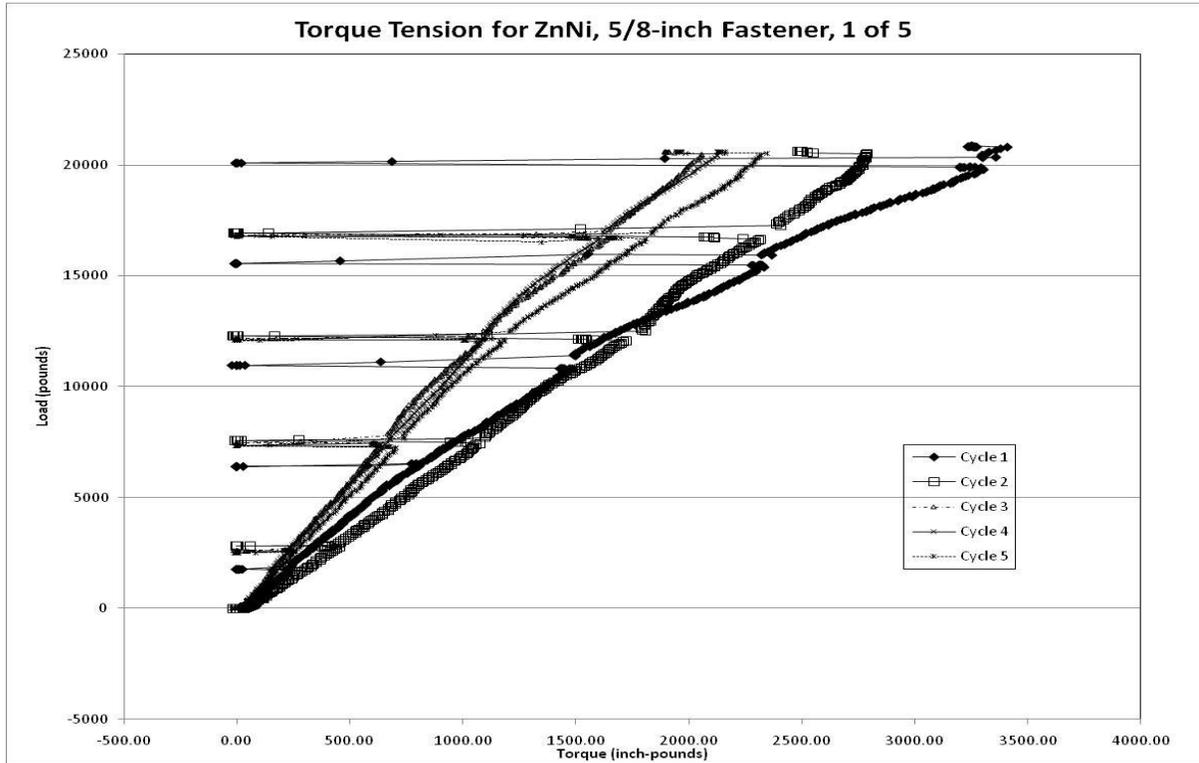
Figure 36. Torque Tension Results for 5/8-inch Fastener Coated with ZnNi

Again, the results for the 5/8-inch fastener have a similar trend as the 3/8-inch fastener, with the torque versus load decreasing for each cycle. Figure 37 shows a graph of a 5/8-inch fastener coated with electroplated Al.

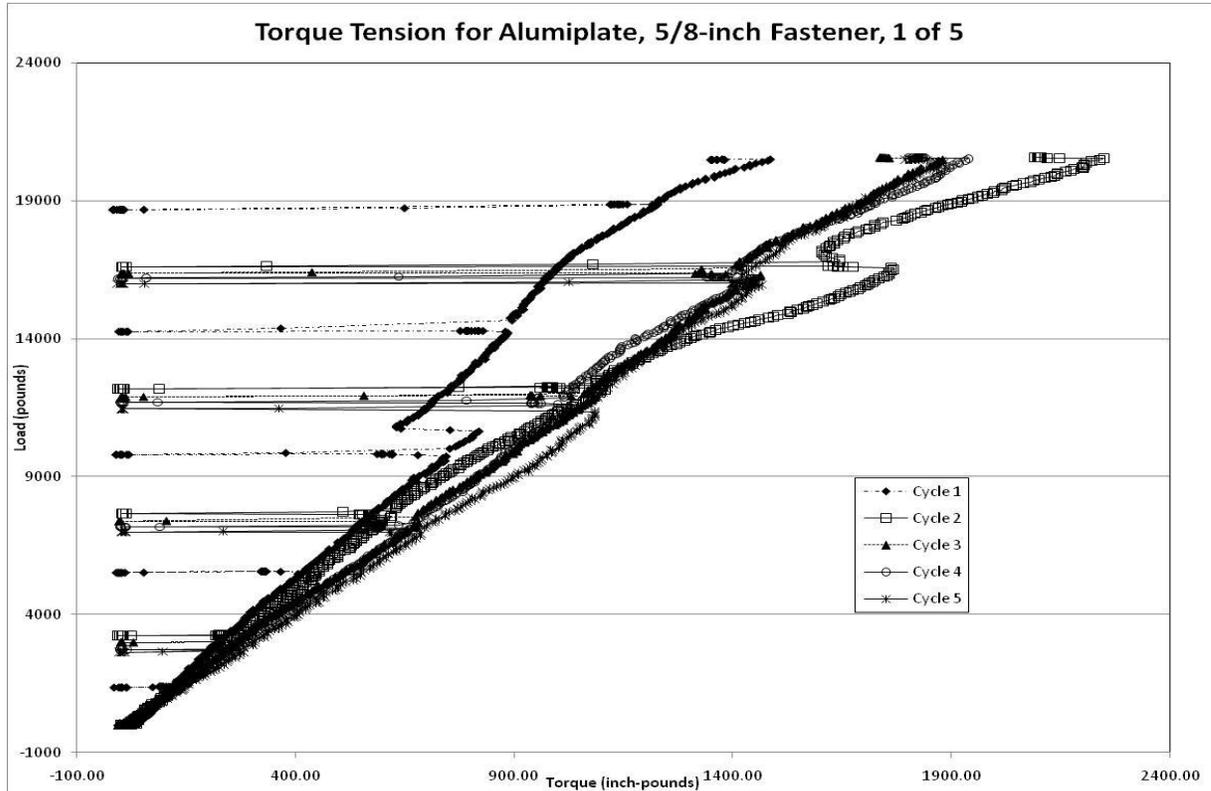
Figure 37. Torque Tension Results for 5/8-inch Fastener Coated with Electroplated Al

This curve does not have a clear trend, showing a lower load versus torque curve for Cycle 1, then the highest torque readings for Cycle 2, with the last three cycles having curves between the first two. In addition, the curves are not as linear as the 3/8-inch fasteners. Finally, Figure 38 contains a graph of the sputtered Al torque tension results.

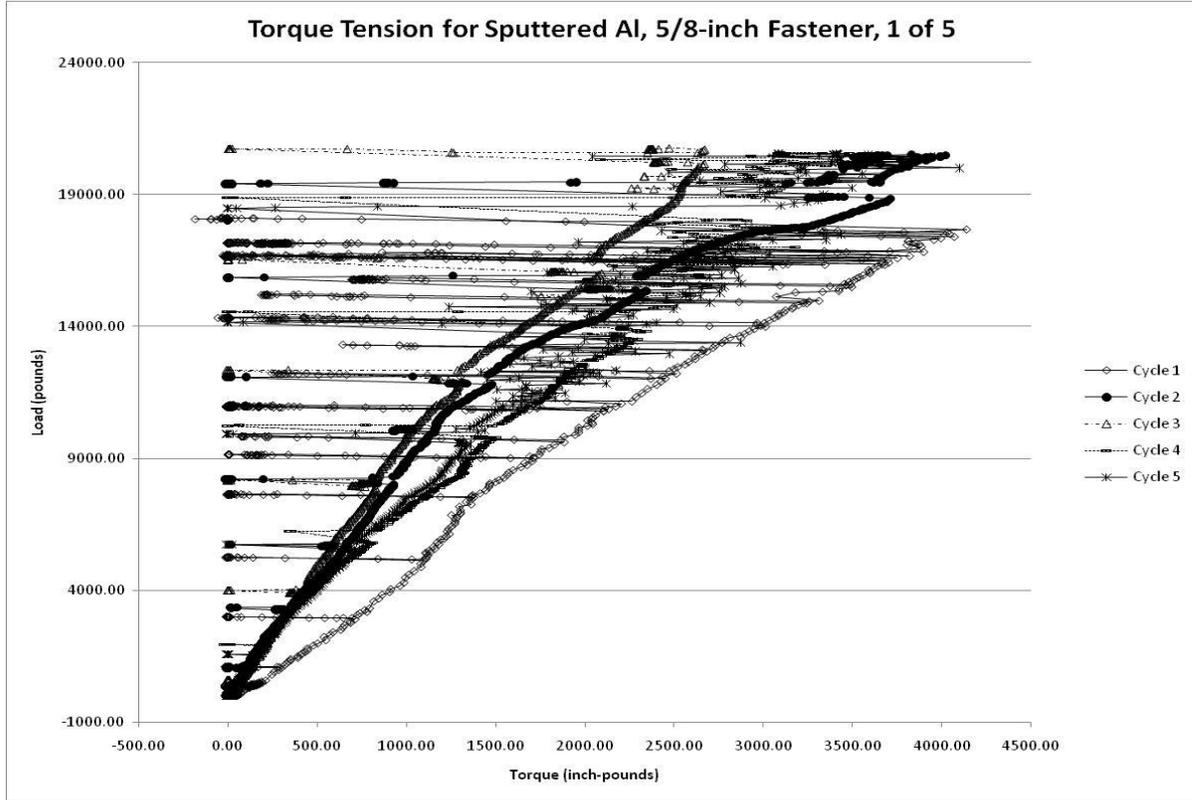
Figure 38. Torque Tension Results for 5/8-inch Fastener Coated with Sputtered Al

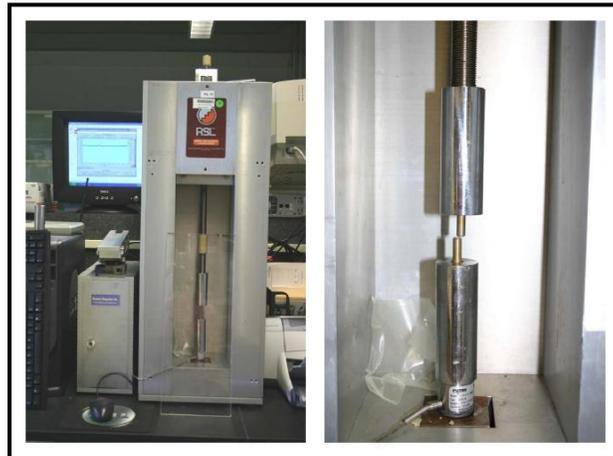
Figure 39 contains a photo of the test equipment utilized at NAVAIR, Patuxent River to conduct the HE testing. Table 27 lists the results of the HE test, which include the fracture strength and time to failure. LHE Zn-Ni was not tested.

Figure 39. Hydrogen Embrittlement Test Equipment

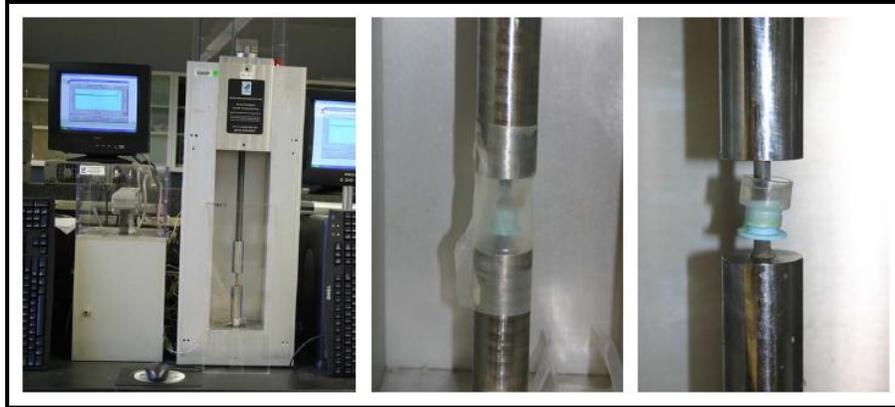
Figure 40 contains a photo of the equipment utilized by NAVAIR PATUXENT River to test for hydrogen re-embrittlement. Figure 40 is followed by Table 27, which lists the results of the testing.

Figure 40. Hydrogen Re-Embrittlement Test Equipment

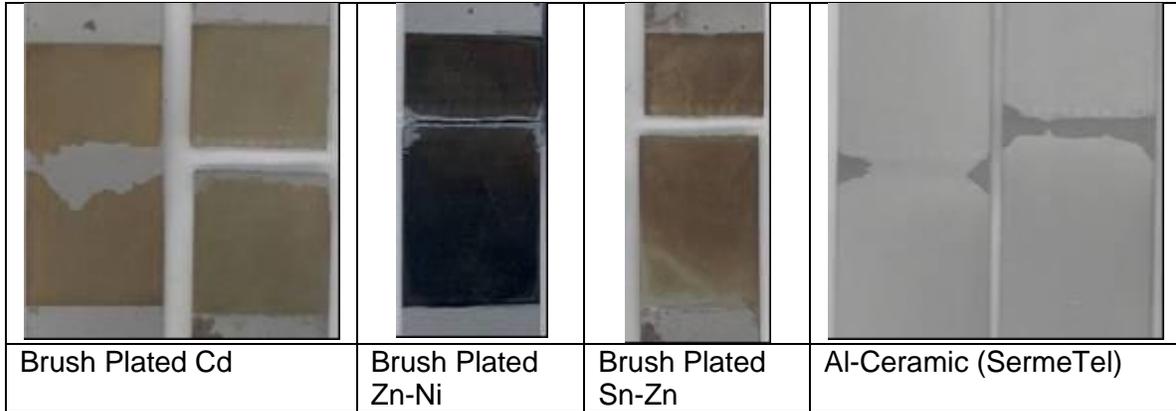
Figure 41. Representative Photos of Bend Adhesion Results for Repair Coatings

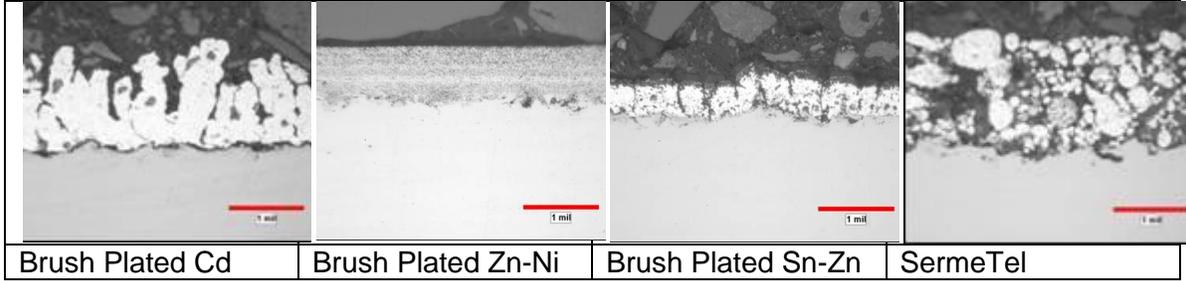
Figure 42. Cross-sectional Images of Coating for Thickness Measurement, 500X

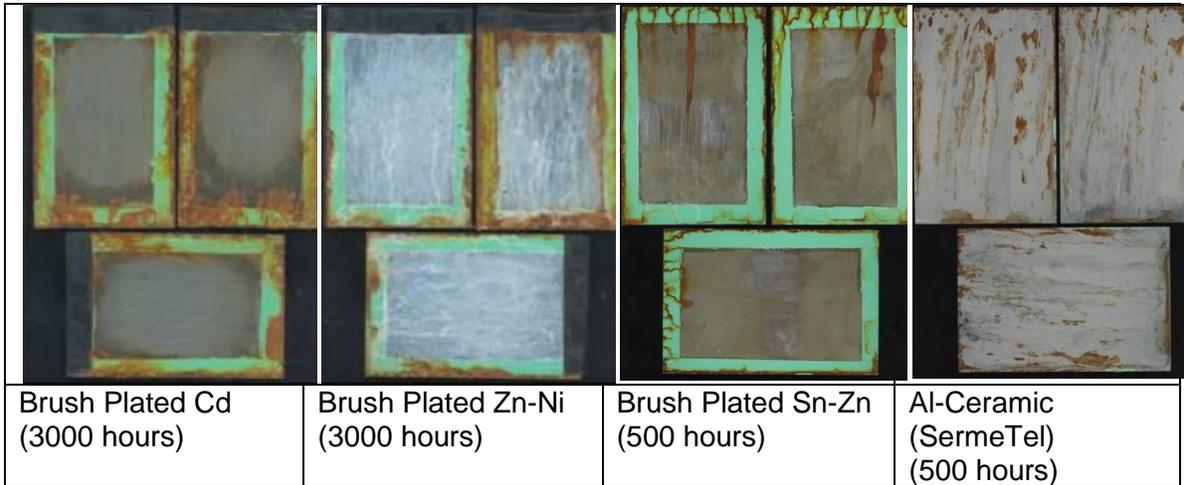
Figure 43. Photos of Unscribed Corrosion Resistance Panels for Repair Coatings

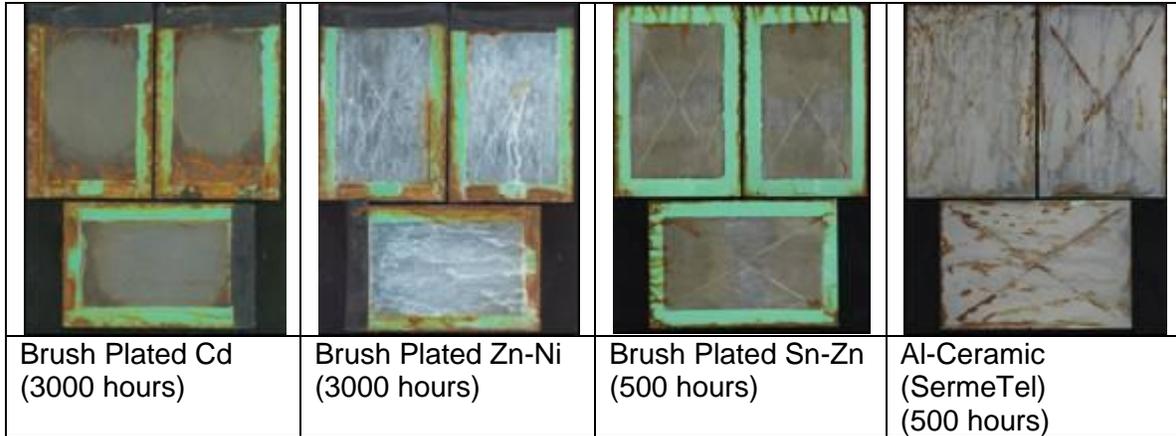
Figure 44. Photographs of Scribed Corrosion Resistance Panels for Repair Coatings
